Access Compliance Report

Public Rights-of-Way

(Curb Ramps)

Intersection ID: 11270	Main Street: ALANBROOK_RD	Cross Street: SIR_BARTON_CT	Location: E
ADA ID: 8EE965C7FBE0	Ramp Type: Perpendicular	Initial Pass/Fail: Pass	Overall Compliance: No
Codes/Mitigation Info/Possible Solution		Field Measurements/Component Compliance	
Severity Score: 17.5

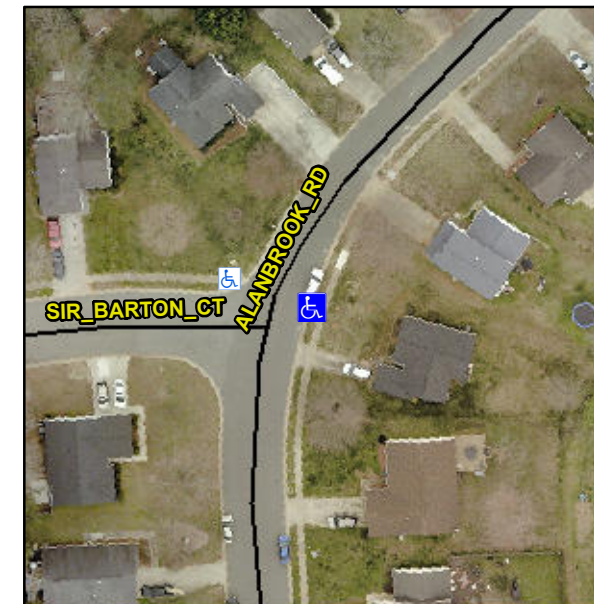
Not Found, R304.2.1, R304.2.2-Perp, R304.3.2-Para, R305, R302.7, R302.7.2

Compliance	Description	Data	Compliance	Description	Data
N/A	Ramp Length (in)	48.5	Yes	Ramp Slope (%)	5.5
Yes	Ramp Width (in)	48.0	Yes	Ramp XSlope (%)	0.9
N/A	Flare Type LT	Sloped	N/A	Flare Type RT	N/A
N/A	Flare Slope LT (%)	4.1	N/A	Flare Slope RT (%)	7.8
N/A	Flare Traversable LT?	No	N/A	Flare Traversable RT?	No
No	Landing Length (in)	47.5	No	DWS Provided?	No
Yes	Landing Width (in)	48.0	N/A	DWS Contrast?	No
No	Landing Slope (%)	2.6	N/A	DWS Length (in)	N/A
Yes	Landing X Slope (%)	0.3	N/A	DWS Full Width?	No
N/A	Landing Curb? (Y/N)	No	N/A	DWS Offset (in)	N/A
N/A	Shared Landing?	No			
No	Gutter Ponding?	Yes	Yes	Gutter Slope (%)	0.7
No	Gutter Lip Ht (in)	0.5	Yes	Gutter X Slope (%)	1.5
N/A	Painted X Walk1?	No	N/A	Painted X Walk2?	N/A
	X Walk 1 Direction	To NW		X Walk 2 Direction	N/A
N/A	X Walk 1 Width (in)	N/A	N/A	X Walk 2 Width (in)	N/A
	X Walk 1 Slope (%)	5.3		X Walk 2 Slope (%)	N/A
	X Walk 1 X Slope (%)	1.5		X Walk 2 X Slope (%)	N/A

N/A	Ramp inside XWalk1?	N/A	N/A	Ramp inside XWalk2?	N/A
	Road Slope (%)	N/A	N/A	Clear Space?	Yes
	Road X Slope (%)	N/A	N/A	Clear Space to XWalk (in)	N/A
Yes	Any Obstructions?	No	Yes	Storm Grate/Utility Hazard?	No
	Obstruction Type			Storm Grate/Utility Type	
		N/A			N/A
			Yes	Surface Condition? (G/P)	Good

Possible Solutions:

Remove & Replace Entire Ramp.
