Access Compliance Report

Public Rights-of-Way

(Curb Ramps)

Intersection ID: 13118	Main Street: E_7TH_ST	Cross Street: CENTRAL_AV	Location: S
ADA ID: 8F02277FD704	Ramp Type: Para	Initial Pass/Fail: Fail	Overall Compliance: No
Severity Score: 26.25			
Codes/Mitigation Info/Possible Solution		Field Measurements/Component Compliance

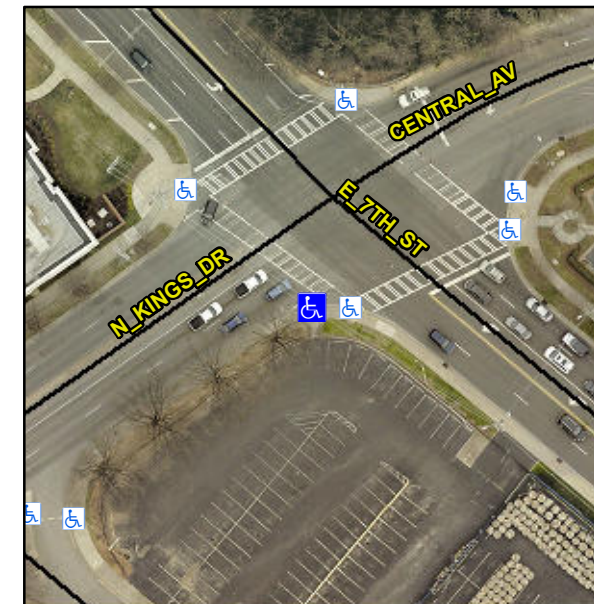
RT RP < 5%

PROW/ADA:

R304.3.2, R304.5.3

Compliance	Description	Data	Compliance	Description	Data
N/A	Ramp Length LT (in)	66.5	N/A	Ramp Length RT (in)	66.0
Yes	Ramp Width LT (in)	60.0	Yes	Ramp Width RT (in)	60.0
No	Ramp Slope LT (%)	12.5	Yes	Ramp Slope RT (%)	0.0
No	Ramp XSlope LT (%)	4.1	No	Ramp XSlope RT (%)	2.9
N/A	Landing Length (in)	N/A	N/A	DWS Provided?	N/A
N/A	Landing Width (in)	N/A	N/A	DWS Contrast?	N/A
N/A	Landing Slope (%)	N/A	N/A	DWS Length (in)	N/A
N/A	Landing X Slope (%)	N/A	N/A	DWS Full Width?	N/A
N/A	Landing Curb? (Y/N)	N/A	N/A	DWS Offset (in)	N/A
N/A	Shared Landing?	N/A			
N/A	Gutter Ponding?	N/A	N/A	Gutter Slope (%)	N/A
N/A	Gutter Lip Ht (in)	N/A	N/A	Gutter X Slope (%)	N/A
N/A	Painted X Walk1?	Yes	N/A	Painted X Walk2?	N/A
	X Walk 1 Direction	To NW		X Walk 2 Direction	N/A
N/A	X Walk 1 Width (in)	110.0	N/A	X Walk 2 Width (in)	N/A
	X Walk 1 Slope (%)	2.0		X Walk 2 Slope (%)	N/A
	X Walk 1 X Slope (%)	5.3		X Walk 2 X Slope (%)	N/A
N/A	Ramp inside XWalk1?	Yes	N/A	Ramp inside XWalk2?	N/A

Possible Solutions:

Remove & Replace Entire Ramp.

Total Cost: \$ 1600.00
