Access Compliance Report

Public Rights-of-Way

(Curb Ramps)

Intersection ID: 10019560	Main Street: ALMA_BLOUNT_BV	Cross Street: N/A	Location: NE
ADA ID: 8F038D5A814E	Ramp Type: Perpendicular Diagonal	Initial Pass/Fail: Fail	Overall Compliance: No
Codes/Mitigation Info/Possible Solution		Field Measurements/Component Compliance

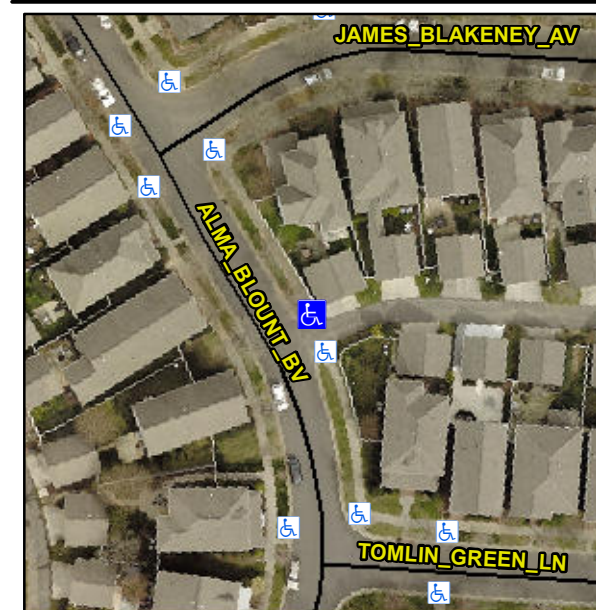
Not Found, R304.5.1, R304.2.2

Compliance	Description	Data	Compliance	Description	Data
N/A	Ramp Length (in)	65.0	No	Ramp Slope (%)	9.7
No	Ramp Width (in)	45.0	Yes	Ramp XSlope (%)	1.9
N/A	Flare Type LT	N/A	N/A	Flare Type RT	N/A
N/A	Flare Slope LT (%)	N/A	N/A	Flare Slope RT (%)	N/A
N/A	Flare Traversable LT?	N/A	N/A	Flare Traversable RT?	N/A
N/A	Landing Length (in)	N/A	N/A	DWS Provided?	N/A
N/A	Landing Width (in)	N/A	N/A	DWS Contrast?	N/A
N/A	Landing Slope (%)	N/A	N/A	DWS Length (in)	N/A
N/A	Landing X Slope (%)	N/A	N/A	DWS Full Width?	N/A
N/A	Landing Curb? (Y/N)	N/A	N/A	DWS Offset (in)	N/A
N/A	Shared Landing?	N/A			
N/A	Gutter Ponding?	N/A	N/A	Gutter Slope (%)	N/A
N/A	Gutter Lip Ht (in)	N/A	N/A	Gutter X Slope (%)	N/A
N/A	Painted X Walk1?	No	N/A	Painted X Walk2?	No
	X Walk 1 Direction	To W		X Walk 2 Direction	To S
N/A	X Walk 1 Width (in)	N/A	N/A	X Walk 2 Width (in)	N/A
	X Walk 1 Slope (%)	2.3		X Walk 2 Slope (%)	2.1
	X Walk 1 X Slope (%)	0.6		X Walk 2 X Slope (%)	1.1

N/A	Ramp inside XWalk1?	N/A	N/A	Ramp inside XWalk2?	N/A
	Road Slope (%)	0.5	N/A	Clear Space?	N/A
	Road X Slope (%)	0.5	N/A	Clear Space to XWalk (in)	N/A
N/A	Any Obstructions?	N/A	N/A	Storm Grate/Utility Hazard?	N/A
	Obstruction Type			Storm Grate/Utility Type	
		N/A			N/A
			Yes	Surface Condition? (G/P)	Good

Possible Solutions:

Remove & Replace Curb Ramp With Two New Directional Ramps or Equivalent.
