# Access Compliance Report

## Public Rights-of-Way

### (Curb Ramps)

| Intersection ID: 14213 | Main Street: CENTRAL_AV | Cross Street: ROSEHAVEN_DR | Location: NW |

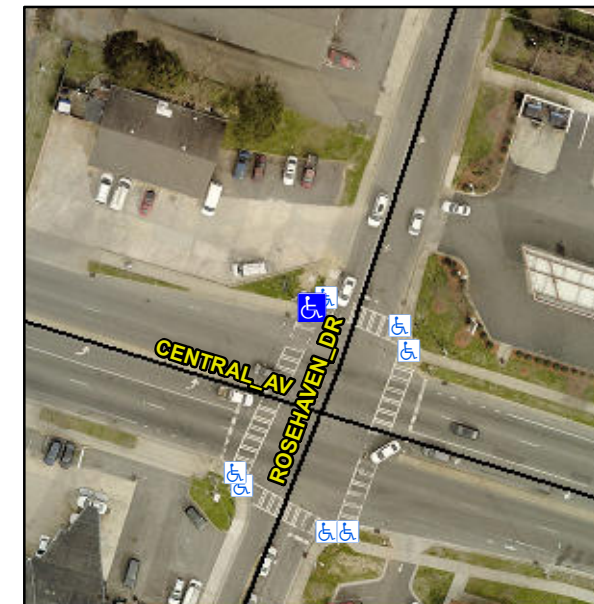
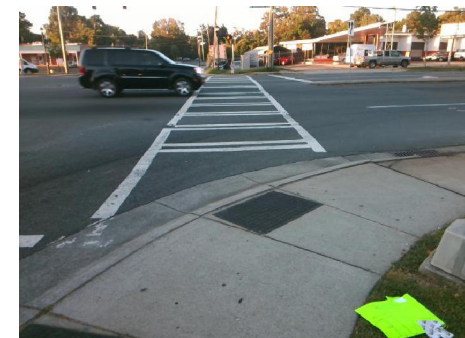
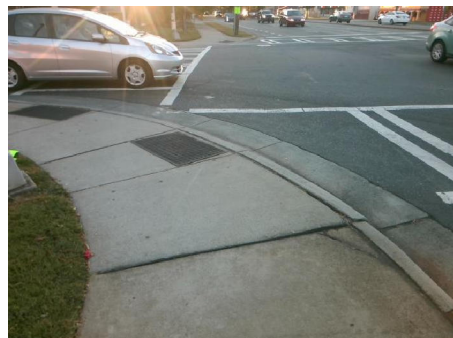
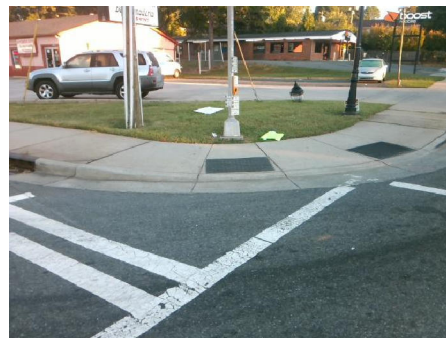
| ADA ID: 8F0C08F70D95 | Ramp Type: BlendTrans1 | Initial Pass/Fail: Fail | Overall Compliance: No |

**Not Found, R304.5.1, R304.5.3**

| Compliance | Description | Data | Compliance | Description | Data |
|---|---|---|---|---|---|
| No | Ramp Width (in) | 32.0 | No | BlendTrans XSlope (%) | 2.4 |
| | | | No | Curb Slope (%) | 21.0 |

**Remove & Replace Curb Ramp With Two New Directional Ramps or Equivalent.**
