# Access Compliance Report

## Public Rights-of-Way

### (Curb Ramps)

Intersection ID: 9489	Main Street: STATESVILLE_AV	Cross Street: KOHLER_AV	Location: NW
ADA ID: 8F179ED27220	Ramp Type: Perpendicular	Initial Pass/Fail: Fail	Overall Compliance: No
		Severity Score: 8.75

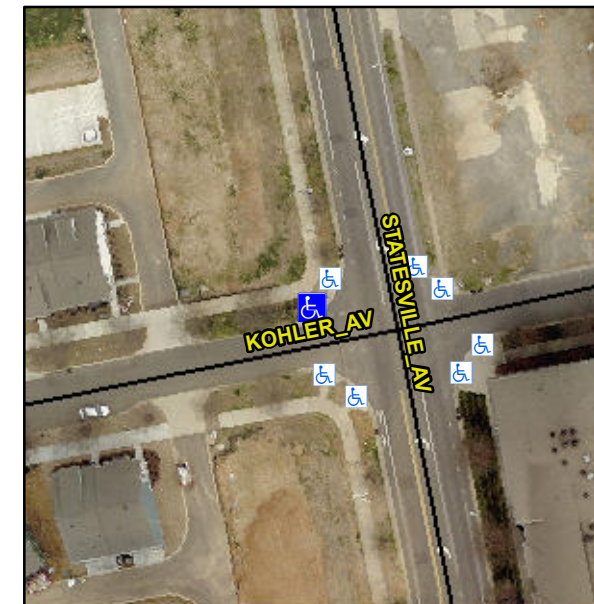
**Not Found, R304.5.1**

Compliance	Description	Data	Compliance	Description	Data
N/A	Ramp Length (in)	72.0	Yes	Ramp Slope (%)	5.9
No	Ramp Width (in)	44.5	Yes	Ramp XSlope (%)	1.9
N/A	Flare Type LT	N/A	N/A	Flare Type RT	N/A
N/A	Flare Slope LT (%)	N/A	N/A	Flare Slope RT (%)	N/A
N/A	Flare Traversable LT?	N/A	N/A	Flare Traversable RT?	N/A
N/A	Landing Length (in)	N/A	N/A	DWS Provided?	N/A
N/A	Landing Width (in)	N/A	N/A	DWS Contrast?	N/A
N/A	Landing Slope (%)	N/A	N/A	DWS Length (in)	N/A
N/A	Landing X Slope (%)	N/A	N/A	DWS Full Width?	N/A
N/A	Landing Curb? (Y/N)	N/A	N/A	DWS Offset (in)	N/A
N/A	Shared Landing?	N/A			
N/A	Gutter Ponding?	N/A	N/A	Gutter Slope (%)	N/A
N/A	Gutter Lip Ht (in)	N/A	N/A	Gutter X Slope (%)	N/A
N/A	Painted X Walk1?	No	N/A	Painted X Walk2?	N/A
	X Walk 1 Direction	To S		X Walk 2 Direction	N/A
N/A	X Walk 1 Width (in)	N/A	N/A	X Walk 2 Width (in)	N/A
	X Walk 1 Slope (%)	0.7		X Walk 2 Slope (%)	N/A
	X Walk 1 X Slope (%)	4.5		X Walk 2 X Slope (%)	N/A

N/A	Ramp inside XWalk1?	N/A	N/A	Ramp inside XWalk2?	N/A
	Road Slope (%)	N/A	N/A	Clear Space?	N/A
	Road X Slope (%)	N/A	N/A	Clear Space to XWalk (in)	N/A
N/A	Any Obstructions?	N/A	N/A	Storm Grate/Utility Hazard?	N/A
	Obstruction Type			Storm Grate/Utility Type	
		N/A			N/A
			Yes	Surface Condition? (G/P)	Good

**Remove & Replace Entire Ramp.**

Total Cost: \$ 1850.00
