# Access Compliance Report

## Public Rights-of-Way

### (Curb Ramps)

| Intersection ID: 16763 | Main Street: BUCKNELL_AV | Cross Street: HASTINGS_DR | Location: NW |

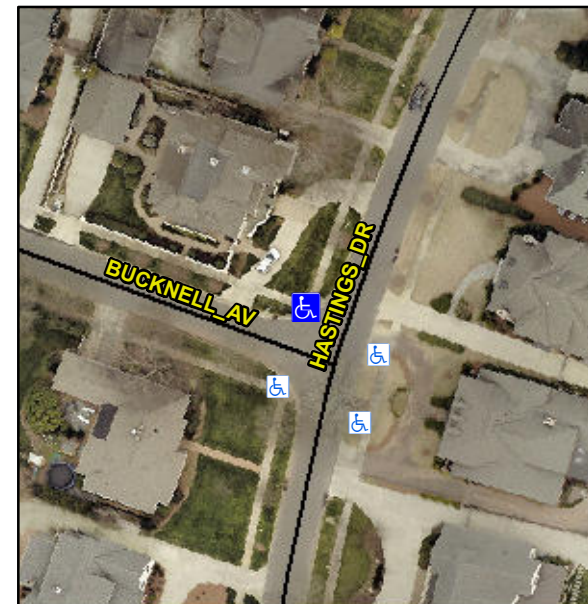
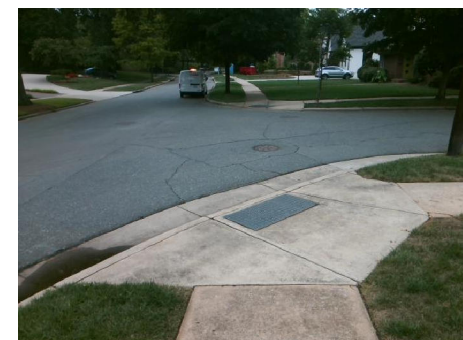
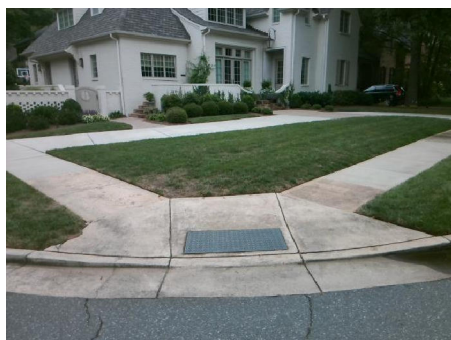
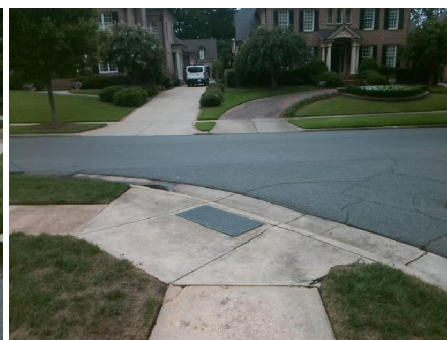
| ADA ID: 8F25B4659B54 | Ramp Type: Perpendicular Diagonal | Initial Pass/Fail: Pass | Overall Compliance: No |

**Not Found, R304.2.1, R304.2.2-Perp, R304.3.2-Para, R304.5.3, R305.2**

| Compliance | Description | Data | Compliance | Description | Data |
|---|---|---|---|---|---|
| No | Landing Length (in) | N/A | Yes | DWS Provided? | Yes |
| No | Landing Width (in) | N/A | Yes | DWS Contrast? | Yes |
| No | Landing Slope (%) | N/A | Yes | DWS Length (in) | 24.0 |
| No | Landing X Slope (%) | N/A | Yes | DWS Full Width? | Yes |
| N/A | Landing Curb? (Y/N) | No | No | DWS Offset (in) | 3.5 |

**Remove & Replace Curb Ramp With Two New Directional Ramps or Equivalent.**

Total Cost: \$ 3200.00
