## **Access Compliance Report Public Rights-of-Way** (Curb Ramps)

Intersection ID: 18055 Main Street: IDLEWILD RD Cross Street: LAILWOOD CR Location: SE **Overall Compliance: No Severity Score:** 1.25 ADA ID: 8F25BFB04F3E Ramp Type: BlendTrans1 Initial Pass/Fail: Fail

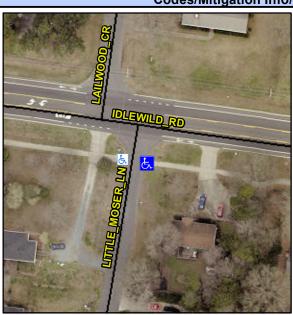
LITTLE MOSER LN Street 1 Name Stop Condition-Street 1 StopSign N/A Street 2 Name Stop Condition-Street 2 N/A Possible Solutions: Compliance Description N/A Remove & Replace Curb Ramp With Two New Directional Ramps or Yes Equivalent. N/A N/A N/A N/A Surveyor Notes: N/A **NO CURB LINE** N/A N/A N/A N/A PROW/ADA: N/A R304.5.3 N/A N/A

No Ramp Width (in) 69.0 BlendTrans XSlope (%) 3.1 N/A Flare Type LT N/A Flare Type RT N/A Flare Slope LT (%) N/A N/A Flare Slope RT (%) N/A Flare Traversable LT? N/A N/A Flare Traversable RT? N/A N/A N/A **DWS Provided?** N/A Landing Length (in) Landing Width (in) N/A N/A **DWS Contrast?** N/A N/A N/A Landing Slope (%) DWS Length (in) N/A Landing X Slope (%) N/A N/A DWS Full Width? N/A Landing Curb? (Y/N) N/A N/A DWS Offset (in) N/A N/A Shared Landing? **Gutter Ponding?** N/A N/A Gutter Slope (%) N/A Gutter Lip Ht (in) N/A N/A Gutter X Slope (%) N/A Painted X Walk1? No N/A Painted X Walk2? N/A X Walk 1 Direction To W X Walk 2 Direction N/A N/A X Walk 1 Width (in) X Walk 2 Width (in) N/A X Walk 1 Slope (%) 2.9 X Walk 2 Slope (%) N/A X Walk 1 X Slope (%) 6.5 X Walk 2 X Slope (%) N/A N/A N/A Ramp inside XWalk2? N/A Ramp inside XWalk1? N/A Road Slope (%) 6.5 Clear Space? N/A Road X Slope (%) 2.9 N/A Clear Space to XWalk (in) N/A N/A N/A N/A Any Obstructions? Storm Grate/Utility Hazard? N/A **Obstruction Type** Storm Grate/Utility Type N/A N/A Yes Surface Condition? (G/P) Good N/A Curb Slope (%) N/A

Total Cost: 3200.00
