Access Compliance Report

Public Rights-of-Way

(Curb Ramps)

Intersection ID: 19730	Main Street: SOUTH_PARK_DR	Cross Street: MORRISON BV	Location: NW
ADA ID: 8F29FD49E3ED	Ramp Type: Perp	Initial Pass/Fail: Fail	Overall Compliance: No
Severity Score: 33.75			
Codes/Mitigation Info/Possible Solution		Field Measurements/Component Compliance

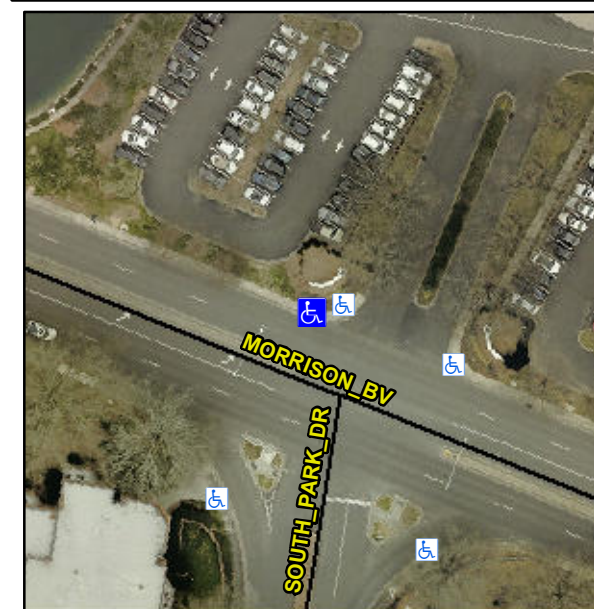
Not Found, R304.5.1, R304.2.2, R304.5.3

Compliance	Description	Data	Compliance	Description	Data
N/A	Ramp Length (in)	46.0	No	Ramp Slope (%)	9.2
No	Ramp Width (in)	47.0	No	Ramp XSlope (%)	5.5
N/A	Flare Type LT	N/A	N/A	Flare Type RT	N/A
N/A	Flare Slope LT (%)	N/A	N/A	Flare Slope RT (%)	N/A
N/A	Flare Traversable LT?	N/A	N/A	Flare Traversable RT?	N/A
N/A	Landing Length (in)	N/A	N/A	DWS Provided?	N/A
N/A	Landing Width (in)	N/A	N/A	DWS Contrast?	N/A
N/A	Landing Slope (%)	N/A	N/A	DWS Length (in)	N/A
N/A	Landing X Slope (%)	N/A	N/A	DWS Full Width?	N/A
N/A	Landing Curb? (Y/N)	N/A	N/A	DWS Offset (in)	N/A
N/A	Shared Landing?	N/A			
N/A	Gutter Ponding?	N/A	N/A	Gutter Slope (%)	N/A
N/A	Gutter Lip Ht (in)	N/A	N/A	Gutter X Slope (%)	N/A
N/A	Painted X Walk1?	No	N/A	Painted X Walk2?	N/A
	X Walk 1 Direction	To S		X Walk 2 Direction	N/A
N/A	X Walk 1 Width (in)	N/A	N/A	X Walk 2 Width (in)	N/A
	X Walk 1 Slope (%)	1.8		X Walk 2 Slope (%)	N/A
	X Walk 1 X Slope (%)	4.5		X Walk 2 X Slope (%)	N/A

N/A	Ramp inside XWalk1?	N/A	N/A	Ramp inside XWalk2?	N/A
	Road Slope (%)	N/A	N/A	Clear Space?	N/A
	Road X Slope (%)	N/A	N/A	Clear Space to XWalk (in)	N/A
N/A	Any Obstructions?	N/A	N/A	Storm Grate/Utility Hazard?	N/A
	Obstruction Type			Storm Grate/Utility Type	
		N/A			N/A
			Yes	Surface Condition? (G/P)	Good

Possible Solutions:

Remove & Replace Entire Ramp.
