# Access Compliance Report

## Public Rights-of-Way

| Intersection ID: 14341 | Main Street: BAY_ST | Cross Street: LORNA_ST | Location: | W |
| ADA ID: 8F2F55D3C5F7 | Ramp Type: Perpendicular Diagonal | Initial Pass/Fail: Fail | Overall Compliance: No | Severity Score: 25 |

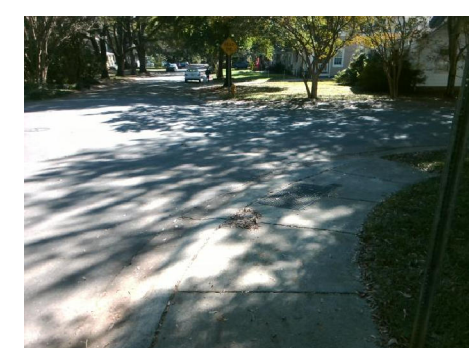
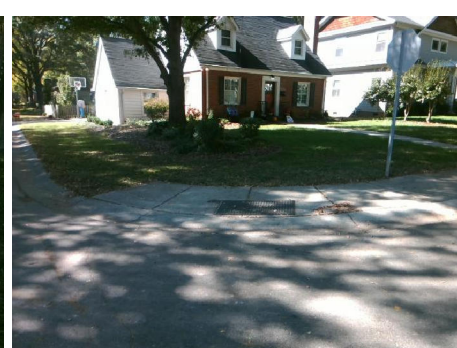
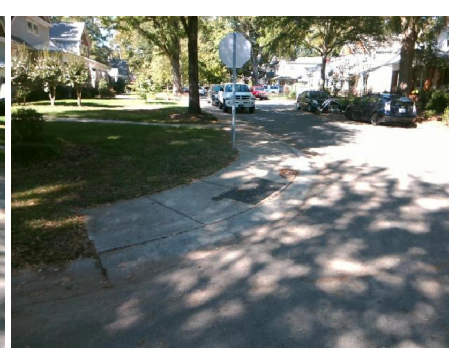
| Codes/Mitigation Info/Possible Solution | | | Field Measurements/Component Compliance | | | | | |
|---|---|---|---|---|---|---|---|---|
| | | | Yes | Ramp Width (in) | 106.0 | No | Ramp XSlope (%) | 8.2 |

| Codes/Mitigation Info/Possible Solution | | | Field Measurements/Component Compliance | | | | | |
|---|---|---|---|---|---|---|---|---|
| | Remove & Replace Curb Ramp With Two New Directional Ramps or Equivalent. | | N/A | Ramp Length (in) | 60.0 | Yes | Ramp Slope (%) | 7.5 |
