Access Compliance Report

Public Rights-of-Way

(Curb Ramps)

Intersection ID: 47843	Main Street: ALVARADO_WY	Cross Street: DEL_RIO_RD	Location: NE
ADA ID: 8F331FA24EA4	Ramp Type: Perpendicular	Initial Pass/Fail: Fail	Overall Compliance: No
Severity Score: 10			
Codes/Mitigation Info/Possible Solution		Field Measurements/Component Compliance

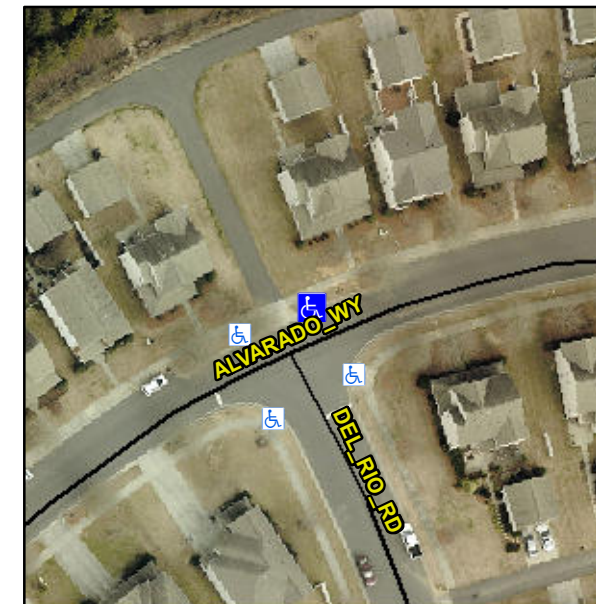
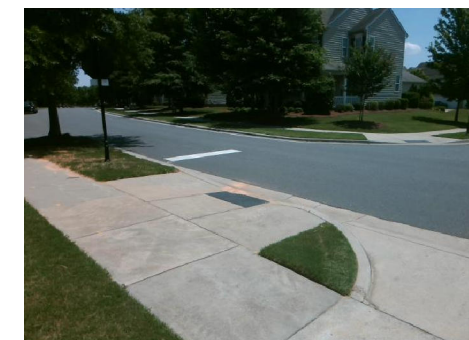
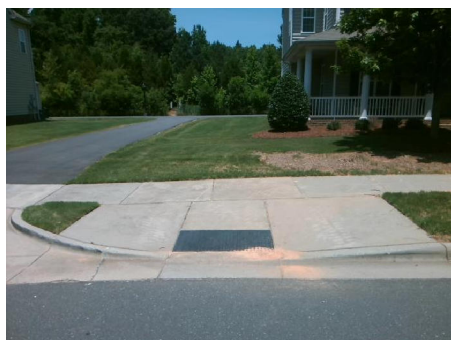
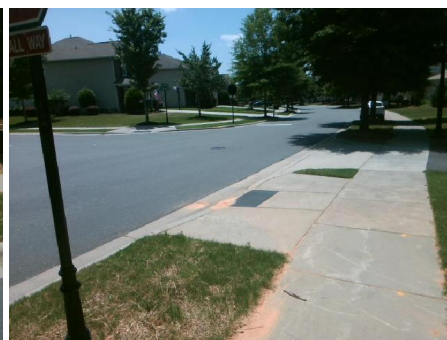
Not Found, R304.5.1, R304.5.3

Compliance	Description	Data	Compliance	Description	Data
N/A	Ramp Length (in)	76.0	Yes	Ramp Slope (%)	5.9
No	Ramp Width (in)	46.5	No	Ramp XSlope (%)	3.0
N/A	Flare Type LT	N/A	N/A	Flare Type RT	N/A
N/A	Flare Slope LT (%)	N/A	N/A	Flare Slope RT (%)	N/A
N/A	Flare Traversable LT?	N/A	N/A	Flare Traversable RT?	N/A
N/A	Landing Length (in)	N/A	N/A	DWS Provided?	N/A
N/A	Landing Width (in)	N/A	N/A	DWS Contrast?	N/A
N/A	Landing Slope (%)	N/A	N/A	DWS Length (in)	N/A
N/A	Landing X Slope (%)	N/A	N/A	DWS Full Width?	N/A
N/A	Landing Curb? (Y/N)	N/A	N/A	DWS Offset (in)	N/A
N/A	Shared Landing?	N/A			
N/A	Gutter Ponding?	N/A	N/A	Gutter Slope (%)	N/A
N/A	Gutter Lip Ht (in)	N/A	N/A	Gutter X Slope (%)	N/A
N/A	Painted X Walk1?	No	N/A	Painted X Walk2?	N/A
	X Walk 1 Direction	To SE		X Walk 2 Direction	N/A
N/A	X Walk 1 Width (in)	N/A	N/A	X Walk 2 Width (in)	N/A
	X Walk 1 Slope (%)	0.7		X Walk 2 Slope (%)	N/A
	X Walk 1 X Slope (%)	1.7		X Walk 2 X Slope (%)	N/A

N/A	Ramp inside XWalk1?	N/A	N/A	Ramp inside XWalk2?	N/A
	Road Slope (%)	N/A	N/A	Clear Space?	N/A
	Road X Slope (%)	N/A	N/A	Clear Space to XWalk (in)	N/A
N/A	Any Obstructions?	N/A	N/A	Storm Grate/Utility Hazard?	N/A
	Obstruction Type			Storm Grate/Utility Type	
		N/A			N/A
			Yes	Surface Condition? (G/P)	Good

Remove & Replace Entire Ramp.
