Access Compliance Report

Public Rights-of-Way

(Curb Ramps)

Intersection ID: 54460	Main Street: STEELE_MEADOW_RD	Cross Street: FLINT_HILL_DR	Location: NW
ADA ID: 8F38C687081A	Ramp Type: BlendTrans1	Initial Pass/Fail: Fail	Overall Compliance: No
		Severity Score: 8.75

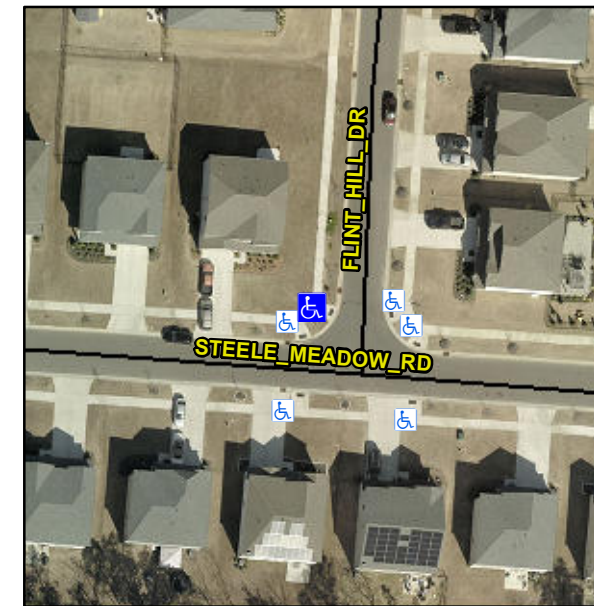
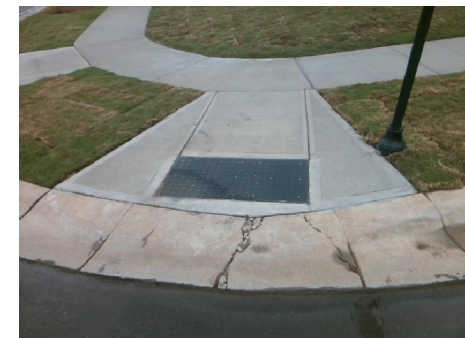
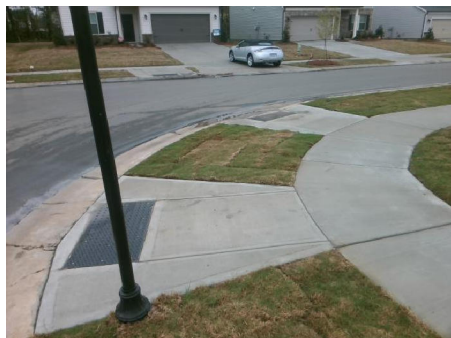
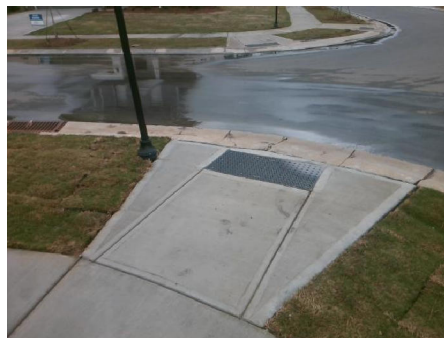
Not Found, R304.5.1

Compliance	Description	Data	Compliance	Description	Data
N/A	Ramp Length (in)	95.0	Yes	BlendTrans Slope (%)	2.1
No	Ramp Width (in)	44.5	Yes	BlendTrans XSlope (%)	1.5
N/A	Flare Type LT	N/A	N/A	Flare Type RT	N/A
N/A	Flare Slope LT (%)	N/A	N/A	Flare Slope RT (%)	N/A
N/A	Flare Traversable LT?	N/A	N/A	Flare Traversable RT?	N/A
N/A	Landing Length (in)	N/A	N/A	DWS Provided?	N/A
N/A	Landing Width (in)	N/A	N/A	DWS Contrast?	N/A
N/A	Landing Slope (%)	N/A	N/A	DWS Length (in)	N/A
N/A	Landing X Slope (%)	N/A	N/A	DWS Full Width?	N/A
N/A	Landing Curb? (Y/N)	N/A	N/A	DWS Offset (in)	N/A
N/A	Shared Landing?	N/A			
N/A	Gutter Ponding?	N/A	N/A	Gutter Slope (%)	N/A
N/A	Gutter Lip Ht (in)	N/A	N/A	Gutter X Slope (%)	N/A
N/A	Painted X Walk1?	No	N/A	Painted X Walk2?	N/A
	X Walk 1 Direction	To E		X Walk 2 Direction	N/A
	X Walk 1 Width (in)	N/A		X Walk 2 Width (in)	N/A
	X Walk 1 Slope (%)	2.5		X Walk 2 Slope (%)	N/A
	X Walk 1 X Slope (%)	0.4		X Walk 2 X Slope (%)	N/A

N/A	Ramp inside XWalk1?	N/A	N/A	Ramp inside XWalk2?	N/A
	Road Slope (%)	0.4		Clear Space?	N/A
	Road X Slope (%)	2.5	N/A	Clear Space to XWalk (in)	N/A
N/A	Any Obstructions?	N/A	N/A	Storm Grate/Utility Hazard?	N/A
	Obstruction Type			Storm Grate/Utility Type	
		N/A			N/A
			Yes	Surface Condition? (G/P)	Good
			No	Curb Slope (%)	6.3

Remove & Replace Curb Ramp With Two New Directional Ramps or Equivalent.
