Access Compliance Report

Public Rights-of-Way

(Curb Ramps)

Intersection ID: 14367	Main Street: E_7TH_ST	Cross Street: N_LAUREL_AV	Location: S
ADA ID: 8F3F0DEA958F	Ramp Type: Perpendicular Diagonal	Initial Pass/Fail: Fail	Overall Compliance: No
		Severity Score: 22.5

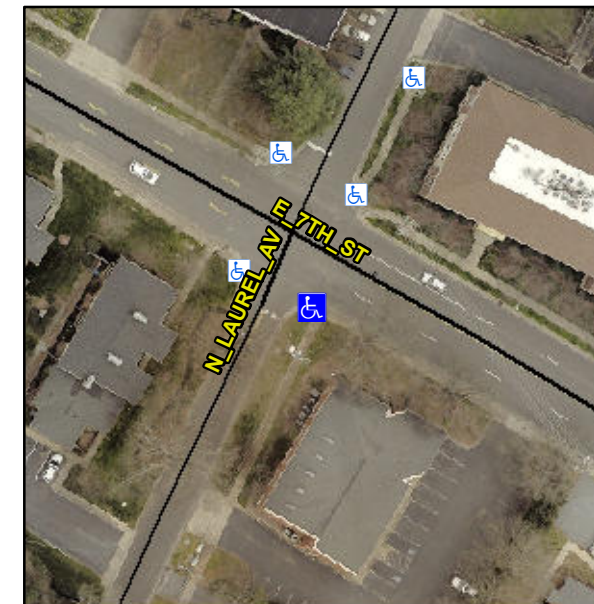
Not Found, R304.5.1, R304.2.2, R304.5.3

Compliance	Description	Data	Compliance	Description	Data
N/A	Ramp Length (in)	70.0	No	Ramp Slope (%)	10.4
No	Ramp Width (in)	41.0	No	Ramp XSlope (%)	3.2
N/A	Flare Type LT	N/A	N/A	Flare Type RT	N/A
N/A	Flare Slope LT (%)	N/A	N/A	Flare Slope RT (%)	N/A
N/A	Flare Traversable LT?	N/A	N/A	Flare Traversable RT?	N/A
N/A	Landing Length (in)	N/A	N/A	DWS Provided?	N/A
N/A	Landing Width (in)	N/A	N/A	DWS Contrast?	N/A
N/A	Landing Slope (%)	N/A	N/A	DWS Length (in)	N/A
N/A	Landing X Slope (%)	N/A	N/A	DWS Full Width?	N/A
N/A	Landing Curb? (Y/N)	N/A	N/A	DWS Offset (in)	N/A
N/A	Shared Landing?	N/A			
N/A	Gutter Ponding?	N/A	N/A	Gutter Slope (%)	N/A
N/A	Gutter Lip Ht (in)	N/A	N/A	Gutter X Slope (%)	N/A
N/A	Painted X Walk1?	No	N/A	Painted X Walk2?	No
	X Walk 1 Direction	To NE		X Walk 2 Direction	To NW
N/A	X Walk 1 Width (in)	N/A	N/A	X Walk 2 Width (in)	N/A
	X Walk 1 Slope (%)	2.6		X Walk 2 Slope (%)	3.5
	X Walk 1 X Slope (%)	1.4		X Walk 2 X Slope (%)	4.0

N/A	Ramp inside XWalk1?	N/A	N/A	Ramp inside XWalk2?	N/A
	Road Slope (%)	1.7	N/A	Clear Space?	N/A
	Road X Slope (%)	5.9	N/A	Clear Space to XWalk (in)	N/A
N/A	Any Obstructions?	N/A	N/A	Storm Grate/Utility Hazard?	N/A
	Obstruction Type			Storm Grate/Utility Type	
		N/A			N/A
			Yes	Surface Condition? (G/P)	Good

Remove & Replace Curb Ramp With Two New Directional Ramps or Equivalent.

Total Cost: \$ 3200.00
