Access Compliance Report

Public Rights-of-Way

(Curb Ramps)

Intersection ID: 11958	Main Street: E_16TH_ST	Cross Street: SEIGLE_AV	Location: W
ADA ID: 8F3F7E890F1D	Ramp Type: Perpendicular	Initial Pass/Fail: Pass	Overall Compliance: No
		Severity Score: 2.5

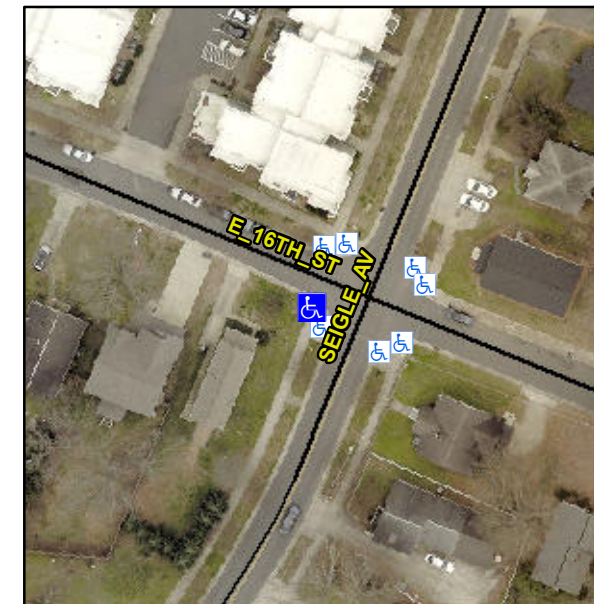
Compliance	Description	Data	Compliance	Description	Data
N/A	Ramp Length (in)	55.0	Yes	Ramp Slope (%)	6.6
Yes	Ramp Width (in)	48.0	Yes	Ramp XSlope (%)	1.3
N/A	Flare Type LT	None	N/A	Flare Type RT	N/A
N/A	Flare Slope LT (%)	N/A	N/A	Flare Slope RT (%)	N/A
N/A	Flare Traversable LT?	N/A	N/A	Flare Traversable RT?	N/A
Yes	Landing Length (in)	58.0	Yes	DWS Provided?	Yes
Yes	Landing Width (in)	72.0	Yes	DWS Contrast?	Yes
Yes	Landing Slope (%)	1.8	Yes	DWS Length (in)	24.5
Yes	Landing X Slope (%)	0.4	No	DWS Full Width?	No
N/A	Landing Curb? (Y/N)	No	No	DWS Offset (in)	12.0
N/A	Shared Landing?	Yes			
Yes	Gutter Ponding?	No	Yes	Gutter Slope (%)	2.1
Yes	Gutter Lip Ht (in)	0.0	No	Gutter X Slope (%)	3.9
N/A	Painted X Walk1?	No	N/A	Painted X Walk2?	N/A
	X Walk 1 Direction	To NE		X Walk 2 Direction	N/A
N/A	X Walk 1 Width (in)	N/A	N/A	X Walk 2 Width (in)	N/A
	X Walk 1 Slope (%)	3.5		X Walk 2 Slope (%)	N/A
	X Walk 1 X Slope (%)	6.2		X Walk 2 X Slope (%)	N/A

N/A	Ramp inside XWalk1?	N/A	N/A	Ramp inside XWalk2?	N/A
	Road Slope (%)	N/A	N/A	Clear Space?	Yes
	Road X Slope (%)	N/A	N/A	Clear Space to XWalk (in)	N/A
Yes	Any Obstructions?	No	Yes	Storm Grate/Utility Hazard?	No
	Obstruction Type			Storm Grate/Utility Type	
		N/A			N/A
			Yes	Surface Condition? (G/P)	Good

Remove & Replace Detectable Warning System. Remove & Replace Gutter.

R305.1.4, R305.2, R304.5.3

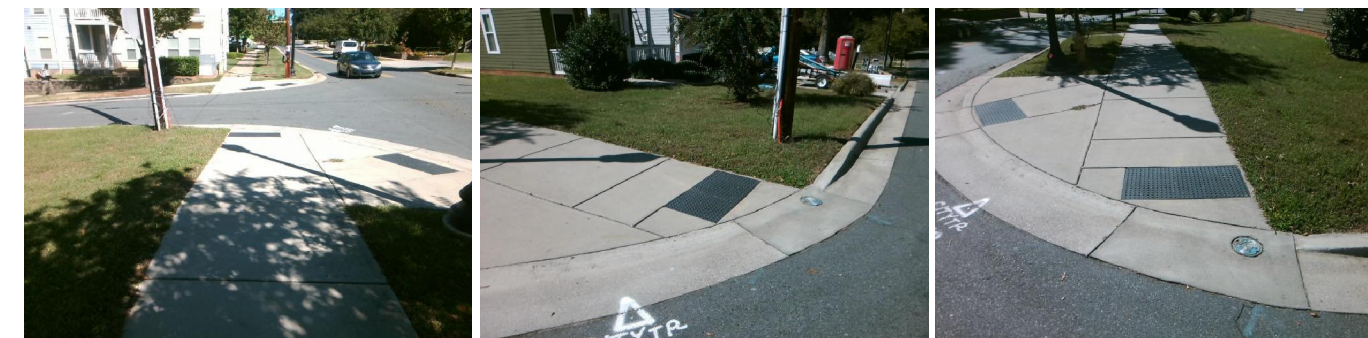
Street 1 Name E 16TH ST
 Stop Condition-Street 2 StopSign
 Street 2 Name N/A
 Stop Condition-Street 1 N/A
