Access Compliance Report

Public Rights-of-Way

(Curb Ramps)

Intersection ID: 18518	Main Street: MURRAYHILL_RD	Cross Street: WEDGEWOOD_DR	Location: NE
ADA ID: 8F43603D97BD	Ramp Type: Directional1	Initial Pass/Fail: Fail	Overall Compliance: No
Severity Score: 1.25			
Codes/Mitigation Info/Possible Solution		Field Measurements/Component Compliance

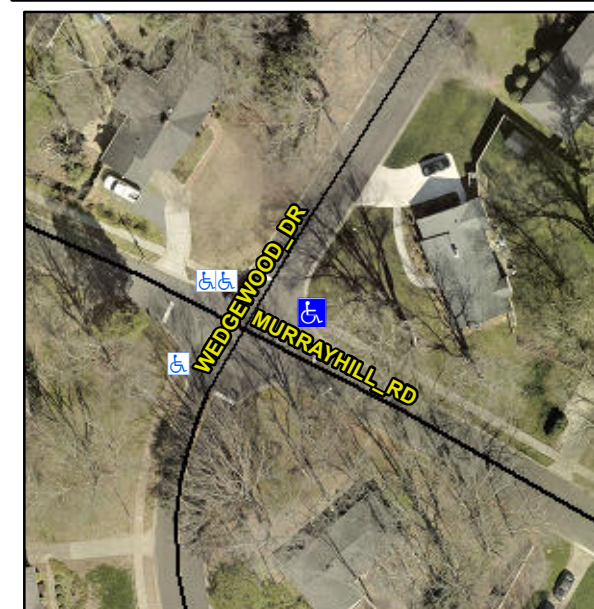
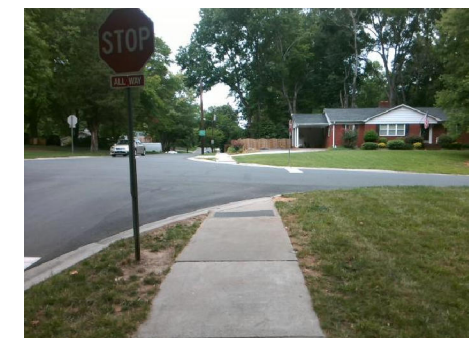
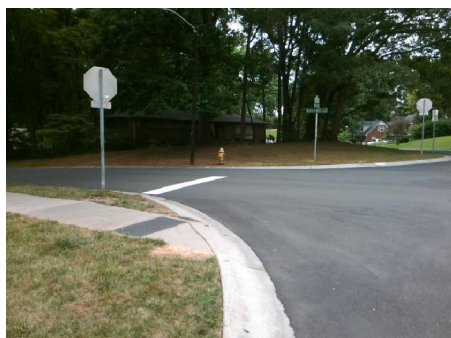
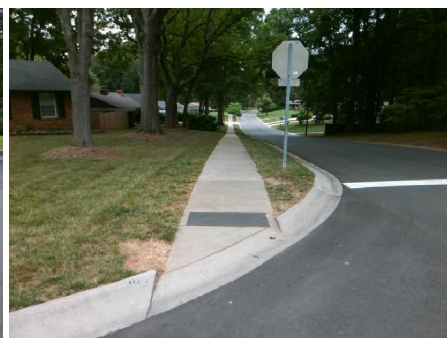
Compliance	Description	Data	Compliance	Description	Data
N/A	Ramp Length (in)	24.0	N/A	Grade Break?	N/A
Yes	Ramp Width (in)	57.0	N/A	Grade Break Slope (%)	0.0
Yes	Ramp Slope (%)	1.6	N/A	Grade Break XSlope (%)	0.0
No	Ramp XSlope (%)	2.7			
N/A	Flare Type LT	N/A	N/A	Flare Type RT	N/A
N/A	Flare Slope LT (%)	N/A	N/A	Flare Slope RT (%)	0.0
N/A	Flare Traversable LT?	N/A	N/A	Flare Traversable RT?	N/A
N/A	Landing Length (in)	0.0	N/A	DWS Provided?	N/A
N/A	Landing Width (in)	0.0	N/A	DWS Contrast?	N/A
N/A	Landing Slope (%)	0.0	N/A	DWS Length (in)	N/A
N/A	Landing X Slope (%)	0.0	N/A	DWS Full Width?	N/A
N/A	Landing Curb? (Y/N)	N/A	N/A	DWS Offset LT (in)	N/A
N/A	Shared Landing?	N/A	N/A	DWS Offset RT (in)	N/A
N/A	Gutter Ponding?	0.0	N/A	Gutter Slope (%)	N/A
N/A	Gutter Lip Ht (in)	0.0	N/A	Gutter X Slope (%)	N/A
N/A	Painted X Walk1?	No		Road Slope (%)	5.8
	X Walk 1 Direction	To W		Road X Slope (%)	2.1
	X Walk 1 Width (in)	N/A		Clear Space?	N/A

X Walk 1 Slope (%)	5.8	N/A	Clear Space to XWalk (in)	N/A
	X Walk 1 X Slope (%)	2.1	N/A	Storm Grate/Utility Hazard?	N/A
N/A	Ramp inside XWalk1?	N/A		Storm Grate/Utility Type	
N/A	Any Obstructions?	N/A			N/A
	Obstruction Type		Yes	Surface Condition? (G/P)	Good
			N/A	Curb Slope (%)	12.2

Possible Solutions:

Remove & Replace Entire Ramp.

R304.5.3
