Access Compliance Report

Public Rights-of-Way

(Curb Ramps)

Intersection ID: 10020495	Main Street: BARCLAY_DOWNS_DR	Cross Street: N/A	Location: NW
ADA ID: 8F496AF91E4B	Ramp Type: Perpendicular	Initial Pass/Fail: Fail	Overall Compliance: No
		Severity Score: 35

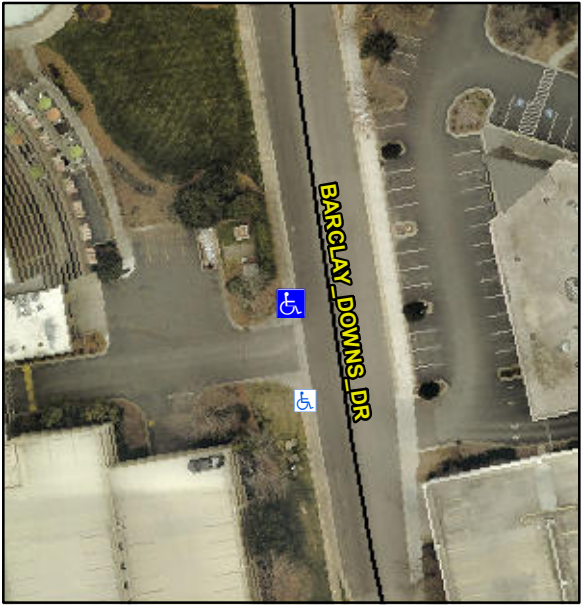
Possible Solutions:		Compliance	Description	Data
	Remove & Replace Entire Ramp.		No	Ramp Length (in)	38.0
			No	Ramp Width (in)	42.0
			N/A	Flare Type LT	N/A
			N/A	Flare Slope LT (%)	N/A
			N/A	Flare Traversable LT?	N/A
			N/A	Landing Length (in)	N/A
			N/A	Landing Width (in)	N/A
			N/A	Landing Slope (%)	N/A
			N/A	Landing X Slope (%)	N/A
<p>Surveyor Notes:</p> <p>N/A</p> <p>PROW/ADA:</p> <p>Not Found, R304.5.1, R304.2.2, R304.5.3</p>			N/A	Landing Curb? (Y/N)	N/A
			N/A	Shared Landing?	N/A
			N/A	Gutter Ponding?	N/A
			N/A	Gutter Lip Ht (in)	N/A
			No	Painted X Walk1?	N/A
				X Walk 1 Direction	To S
			N/A	X Walk 1 Width (in)	N/A
				X Walk 1 Slope (%)	2.4
				X Walk 1 X Slope (%)	0.7
			N/A	Ramp inside XWalk1?	N/A
<p>Street 1 Name</p> <p>Stop Condition-Street 2</p> <p>Street 2 Name</p> <p>Stop Condition-Street 1</p>			N/A	Road Slope (%)	N/A

N/A	Road X Slope (%)	N/A
			N/A	Any Obstructions?	N/A
				Obstruction Type	
			N/A		
			N/A		
			N/A		
			N/A		
			N/A		
			N/A		
<p>Total Cost:</p> <p>\$ 1850.00</p>			N/A		
			N/A		
			Yes	Surface Condition? (G/P)	Good
