# Access Compliance Report

## Public Rights-of-Way

| Intersection ID: 20090 | Main Street: OLD_PINEVILLE_RD | Cross Street: LAKEMIST_DR | Location: SW |
| ADA ID: 8F4994DB7ECD | Ramp Type: Perpendicular Diagonal | Initial Pass/Fail: Pass | Overall Compliance: No |

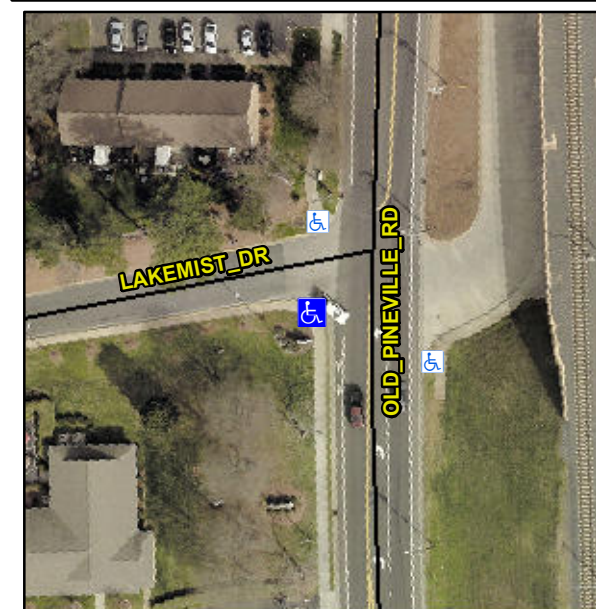
**Not Found, R304.2.1, R304.2.2-Perp, R304.3.2-Para, R304.5.3, R305.2, R304.5.4**

| Compliance | Description | Data | Compliance | Description | Data |
|---|---|---|---|---|---|
| No | Landing Length (in) | N/A | Yes | DWS Provided? | Yes |
| No | Landing Width (in) | N/A | Yes | DWS Contrast? | Yes |
| No | Landing Slope (%) | N/A | Yes | DWS Length (in) | 24.5 |
| No | Landing X Slope (%) | N/A | Yes | DWS Full Width? | Yes |
| N/A | Landing Curb? (Y/N) | No | No | DWS Offset (in) | 3.5 |
| Yes | Gutter Ponding? | No | No | Gutter Slope (%) | 5.9 |

**Remove & Replace Curb Ramp With Two New Directional Ramps or Equivalent. Remove & Replace Gutter.**
