# Access Compliance Report

## Public Rights-of-Way

### (Curb Ramps)

Intersection ID: 50588	Main Street: BENDING_BRANCH_RD	Cross Street: DOWNY_BIRCH_RD	Location: NW
ADA ID: 8F525BC01238	Ramp Type: Perpendicular	Initial Pass/Fail: Fail	Overall Compliance: No
		Severity Score: 8.75

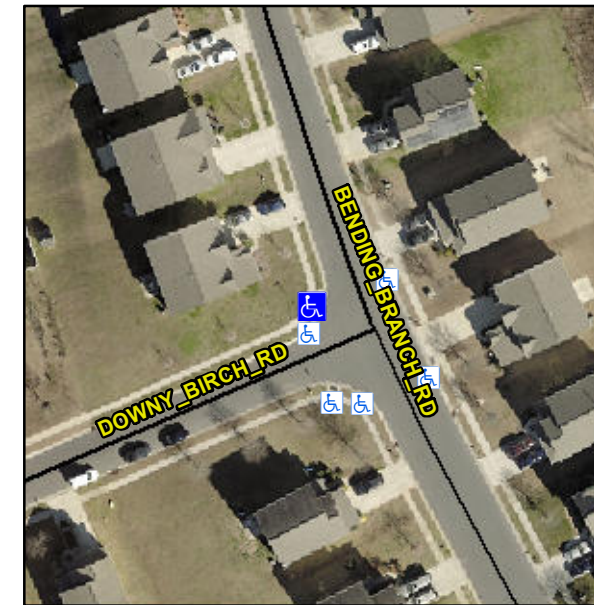
**Not Found, R304.5.1**

Compliance	Description	Data	Compliance	Description	Data
N/A	Ramp Length (in)	47.5	Yes	Ramp Slope (%)	6.6
No	Ramp Width (in)	47.5	Yes	Ramp XSlope (%)	1.9
N/A	Flare Type LT	N/A	N/A	Flare Type RT	N/A
N/A	Flare Slope LT (%)	N/A	N/A	Flare Slope RT (%)	N/A
N/A	Flare Traversable LT?	N/A	N/A	Flare Traversable RT?	N/A
N/A	Landing Length (in)	N/A	N/A	DWS Provided?	N/A
N/A	Landing Width (in)	N/A	N/A	DWS Contrast?	N/A
N/A	Landing Slope (%)	N/A	N/A	DWS Length (in)	N/A
N/A	Landing X Slope (%)	N/A	N/A	DWS Full Width?	N/A
N/A	Landing Curb? (Y/N)	N/A	N/A	DWS Offset (in)	N/A
N/A	Shared Landing?	N/A			
N/A	Gutter Ponding?	N/A	N/A	Gutter Slope (%)	N/A
N/A	Gutter Lip Ht (in)	N/A	N/A	Gutter X Slope (%)	N/A
N/A	Painted X Walk1?	No	N/A	Painted X Walk2?	N/A
	X Walk 1 Direction	To E		X Walk 2 Direction	N/A
N/A	X Walk 1 Width (in)	N/A	N/A	X Walk 2 Width (in)	N/A
	X Walk 1 Slope (%)	2.6		X Walk 2 Slope (%)	N/A
	X Walk 1 X Slope (%)	2.4		X Walk 2 X Slope (%)	N/A

N/A	Ramp inside XWalk1?	N/A	N/A	Ramp inside XWalk2?	N/A
	Road Slope (%)	N/A	N/A	Clear Space?	N/A
	Road X Slope (%)	N/A	N/A	Clear Space to XWalk (in)	N/A
N/A	Any Obstructions?	N/A	N/A	Storm Grate/Utility Hazard?	N/A
	Obstruction Type			Storm Grate/Utility Type	
		N/A			N/A
			Yes	Surface Condition? (G/P)	Good

**Remove & Replace Entire Ramp.**

Total Cost: \$ 1850.00
