Access Compliance Report

Public Rights-of-Way

(Curb Ramps)

Intersection ID: 9616	Main Street: BRIARWOOD_DR	Cross Street: THE_PLAZA	Location: NE
ADA ID: 8F5994D213E3	Ramp Type: Perpendicular	Initial Pass/Fail: Fail	Overall Compliance: No
		Severity Score: 12.5

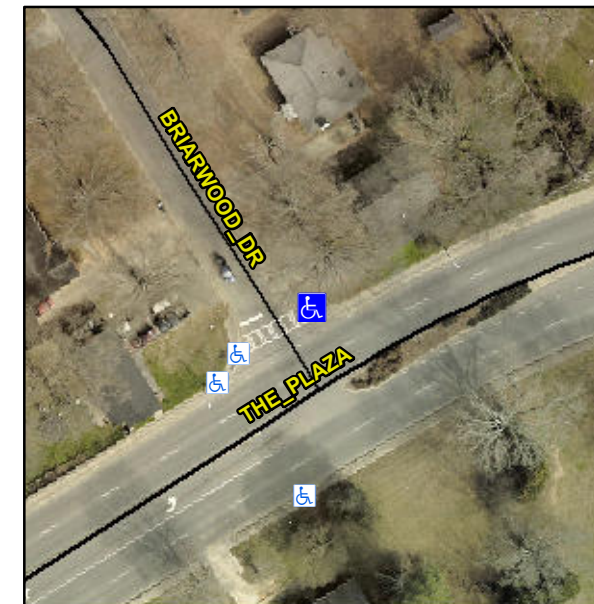
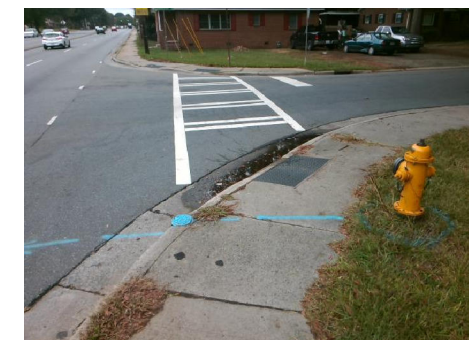
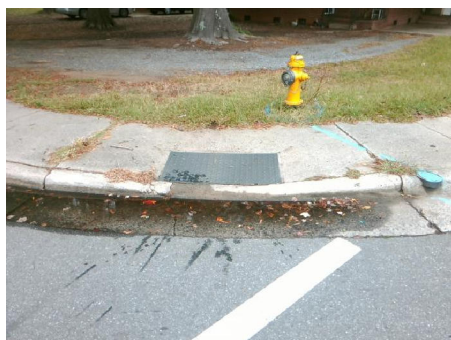
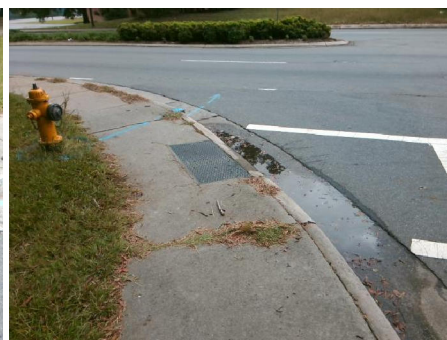
Not Found, R304.2.2

Compliance	Description	Data	Compliance	Description	Data
N/A	Ramp Length (in)	60.0	No	Ramp Slope (%)	8.4
Yes	Ramp Width (in)	48.0	Yes	Ramp XSlope (%)	0.3
N/A	Flare Type LT	N/A	N/A	Flare Type RT	N/A
N/A	Flare Slope LT (%)	N/A	N/A	Flare Slope RT (%)	N/A
N/A	Flare Traversable LT?	N/A	N/A	Flare Traversable RT?	N/A
N/A	Landing Length (in)	N/A	N/A	DWS Provided?	N/A
N/A	Landing Width (in)	N/A	N/A	DWS Contrast?	N/A
N/A	Landing Slope (%)	N/A	N/A	DWS Length (in)	N/A
N/A	Landing X Slope (%)	N/A	N/A	DWS Full Width?	N/A
N/A	Landing Curb? (Y/N)	N/A	N/A	DWS Offset (in)	N/A
N/A	Shared Landing?	N/A			
N/A	Gutter Ponding?	Yes	N/A	Gutter Slope (%)	N/A
N/A	Gutter Lip Ht (in)	N/A	N/A	Gutter X Slope (%)	N/A
N/A	Painted X Walk1?	Yes	N/A	Painted X Walk2?	N/A
	X Walk 1 Direction	To SW		X Walk 2 Direction	N/A
N/A	X Walk 1 Width (in)	88.0	N/A	X Walk 2 Width (in)	N/A
	X Walk 1 Slope (%)	3.4		X Walk 2 Slope (%)	N/A
	X Walk 1 X Slope (%)	0.2		X Walk 2 X Slope (%)	N/A

N/A	Ramp inside XWalk1?	Yes	N/A	Ramp inside XWalk2?	N/A
	Road Slope (%)	N/A	N/A	Clear Space?	N/A
	Road X Slope (%)	N/A	N/A	Clear Space to XWalk (in)	N/A
N/A	Any Obstructions?	N/A	N/A	Storm Grate/Utility Hazard?	N/A
	Obstruction Type			Storm Grate/Utility Type	
		N/A			N/A
			Yes	Surface Condition? (G/P)	Good

Possible Solutions:

Remove & Replace Entire Ramp.
