# Access Compliance Report

## Public Rights-of-Way

### (Curb Ramps)

| Intersection ID: 2852 | Main Street: EDINMEADOW_LN | Cross Street: HUNTMEADOW_DR | Location: SE |

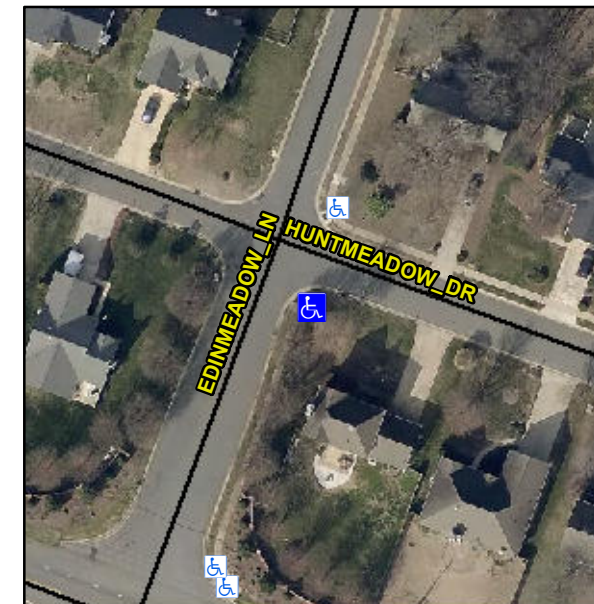
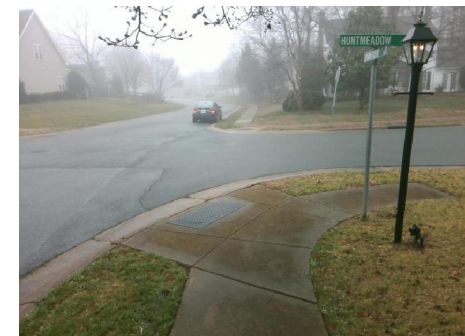
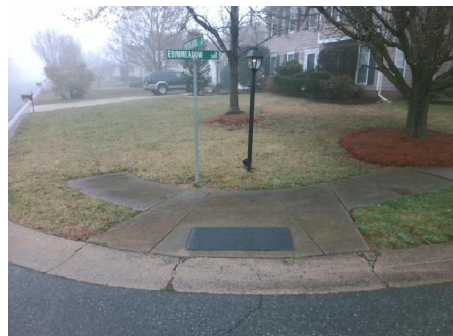
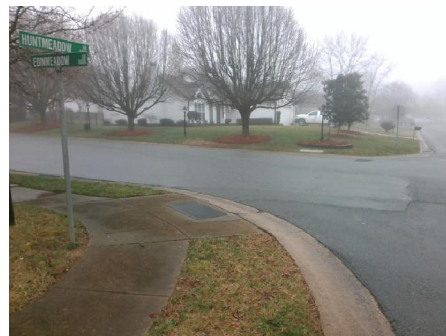
| ADA ID: 8F63A26BDE9C | Ramp Type: BlendTrans1 | Initial Pass/Fail: Fail | Overall Compliance: No |
| Severity Score: 1.25 | | | |

**Not Found, R304.5.3**

| Compliance | Description | Data | Compliance | Description | Data |
|---|---|---|---|---|---|
| Yes | Ramp Width (in) | 57.0 | No | BlendTrans XSlope (%) | 3.5 |
| | | | No | Curb Slope (%) | 15.7 |

**Remove & Replace Curb Ramp With Two New Directional Ramps or Equivalent.**

Total Cost: \$ 3200.00
