# Access Compliance Report

## Public Rights-of-Way

### (Curb Ramps)

Intersection ID: 45064	Main Street: CHALKSTONE_RD	Cross Street: ESCAFLWNE_AV	Location: SE
ADA ID: 8F6C891BD4D2	Ramp Type: Perpendicular	Initial Pass/Fail: Fail	Overall Compliance: No
Severity Score: 21.25			
Codes/Mitigation Info/Possible Solution		Field Measurements/Component Compliance

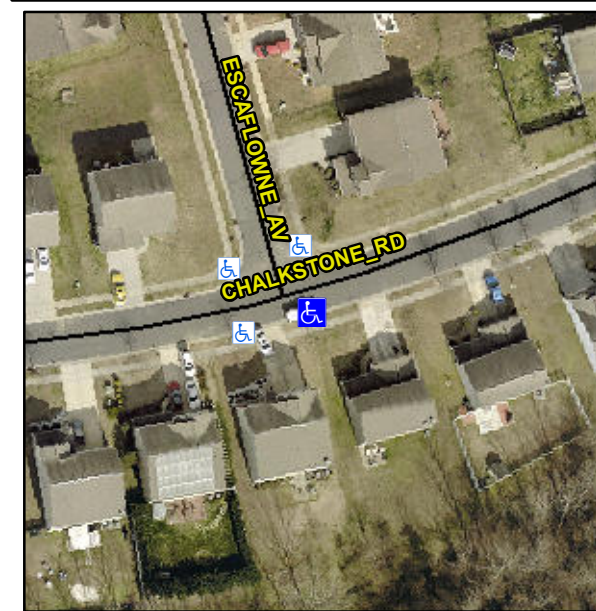
**Not Found, R304.5.1, R304.2.2**

Compliance	Description	Data	Compliance	Description	Data
N/A	Ramp Length (in)	48.0	No	Ramp Slope (%)	9.0
No	Ramp Width (in)	47.5	Yes	Ramp XSlope (%)	1.7
N/A	Flare Type LT	N/A	N/A	Flare Type RT	N/A
N/A	Flare Slope LT (%)	N/A	N/A	Flare Slope RT (%)	N/A
N/A	Flare Traversable LT?	N/A	N/A	Flare Traversable RT?	N/A
N/A	Landing Length (in)	N/A	N/A	DWS Provided?	N/A
N/A	Landing Width (in)	N/A	N/A	DWS Contrast?	N/A
N/A	Landing Slope (%)	N/A	N/A	DWS Length (in)	N/A
N/A	Landing X Slope (%)	N/A	N/A	DWS Full Width?	N/A
N/A	Landing Curb? (Y/N)	N/A	N/A	DWS Offset (in)	N/A
N/A	Shared Landing?	N/A			
N/A	Gutter Ponding?	N/A	N/A	Gutter Slope (%)	N/A
N/A	Gutter Lip Ht (in)	N/A	N/A	Gutter X Slope (%)	N/A
N/A	Painted X Walk1?	No	N/A	Painted X Walk2?	N/A
	X Walk 1 Direction	To N		X Walk 2 Direction	N/A
N/A	X Walk 1 Width (in)	N/A	N/A	X Walk 2 Width (in)	N/A
	X Walk 1 Slope (%)	4.2		X Walk 2 Slope (%)	N/A
	X Walk 1 X Slope (%)	1.2		X Walk 2 X Slope (%)	N/A

N/A	Ramp inside XWalk1?	N/A	N/A	Ramp inside XWalk2?	N/A
	Road Slope (%)	N/A	N/A	Clear Space?	N/A
	Road X Slope (%)	N/A	N/A	Clear Space to XWalk (in)	N/A
N/A	Any Obstructions?	N/A	N/A	Storm Grate/Utility Hazard?	N/A
	Obstruction Type			Storm Grate/Utility Type	
		N/A			N/A
			Yes	Surface Condition? (G/P)	Good

**Remove & Replace Entire Ramp.**
