Access Compliance Report

Public Rights-of-Way

(Curb Ramps)

Intersection ID: 18350	Main Street: PROVIDENCE_RD	Cross Street: SHARON_LN	Location: W
ADA ID: 8F6D19D95BF5	Ramp Type: Para	Initial Pass/Fail: Fail	Overall Compliance: No
Codes/Mitigation Info/Possible Solution		Field Measurements/Component Compliance

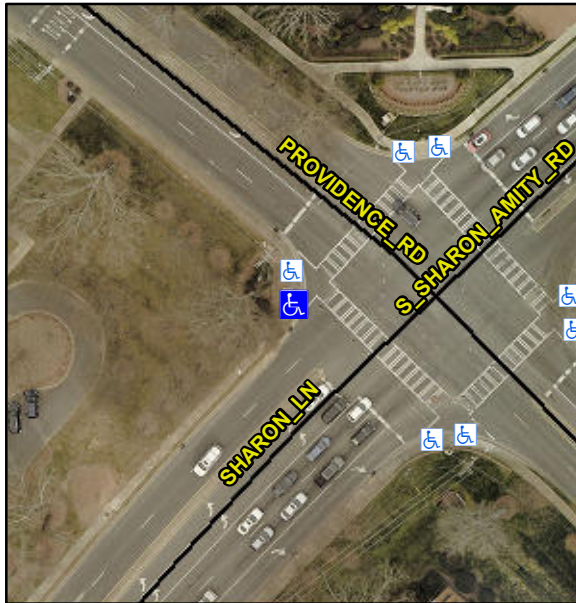
R304.3.2, R304.5.3

Compliance	Description	Data	Compliance	Description	Data
N/A	Ramp Length LT (in)	57.0	N/A	Ramp Length RT (in)	60.0
Yes	Ramp Width LT (in)	78.0	Yes	Ramp Width RT (in)	83.0
No	Ramp Slope LT (%)	10.4	Yes	Ramp Slope RT (%)	5.0
No	Ramp XSlope LT (%)	2.9	No	Ramp XSlope RT (%)	3.0
N/A	Landing Length (in)	N/A	N/A	DWS Provided?	N/A
N/A	Landing Width (in)	N/A	N/A	DWS Contrast?	N/A
N/A	Landing Slope (%)	N/A	N/A	DWS Length (in)	N/A
N/A	Landing X Slope (%)	N/A	N/A	DWS Full Width?	N/A
N/A	Landing Curb? (Y/N)	N/A	N/A	DWS Offset (in)	N/A
N/A	Shared Landing?	N/A			
N/A	Gutter Ponding?	N/A	N/A	Gutter Slope (%)	N/A
N/A	Gutter Lip Ht (in)	N/A	N/A	Gutter X Slope (%)	N/A
N/A	Painted X Walk1?	Yes	N/A	Painted X Walk2?	N/A
	X Walk 1 Direction	To SE		X Walk 2 Direction	N/A
N/A	X Walk 1 Width (in)	110.0	N/A	X Walk 2 Width (in)	N/A
	X Walk 1 Slope (%)	1.1		X Walk 2 Slope (%)	N/A
	X Walk 1 X Slope (%)	1.4		X Walk 2 X Slope (%)	N/A
N/A	Ramp inside XWalk1?	Yes	N/A	Ramp inside XWalk2?	N/A

Road Slope (%)	N/A	N/A	Clear Space?	N/A
	Road X Slope (%)	N/A	N/A	Clear Space to XWalk (in)	N/A
N/A	Any Obstructions?	N/A	N/A	Storm Grate/Utility Hazard?	N/A
	Obstruction Type			Storm Grate/Utility Type	
		N/A			N/A
			Yes	Surface Condition? (G/P)	Good
			N/A	Curb Slope (%)	20.3

Possible Solutions:

Remove & Replace Entire Ramp.
