Access Compliance Report

Public Rights-of-Way

(Curb Ramps)

Intersection ID: 23910	Main Street: KNIGHTSWOOD_DR	Cross Street: WINDYRUSH_RD	Location: SE
ADA ID: 8F70C53165E9	Ramp Type: Perpendicular Diagonal	Initial Pass/Fail: Fail	Overall Compliance: No
		Severity Score: 8.75

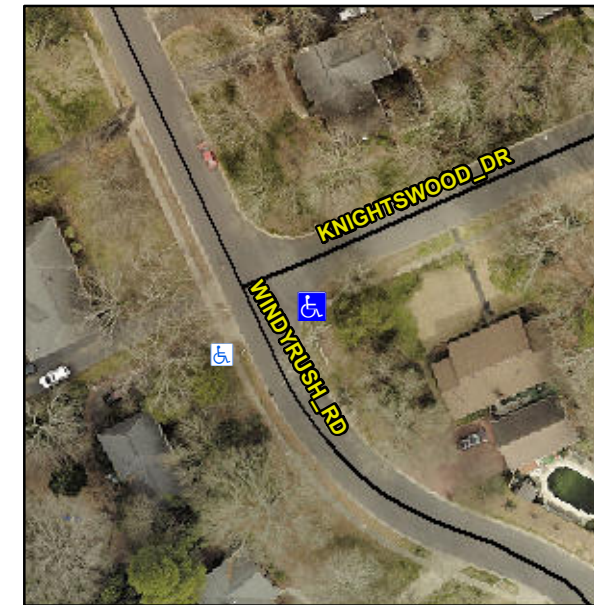
Not Found, R304.5.1

Compliance	Description	Data	Compliance	Description	Data
N/A	Ramp Length (in)	72.0	Yes	Ramp Slope (%)	6.8
No	Ramp Width (in)	47.5	Yes	Ramp XSlope (%)	2.0
N/A	Flare Type LT	N/A	N/A	Flare Type RT	N/A
N/A	Flare Slope LT (%)	N/A	N/A	Flare Slope RT (%)	N/A
N/A	Flare Traversable LT?	N/A	N/A	Flare Traversable RT?	N/A
N/A	Landing Length (in)	N/A	N/A	DWS Provided?	N/A
N/A	Landing Width (in)	N/A	N/A	DWS Contrast?	N/A
N/A	Landing Slope (%)	N/A	N/A	DWS Length (in)	N/A
N/A	Landing X Slope (%)	N/A	N/A	DWS Full Width?	N/A
N/A	Landing Curb? (Y/N)	N/A	N/A	DWS Offset (in)	N/A
N/A	Shared Landing?	N/A			
N/A	Gutter Ponding?	N/A	N/A	Gutter Slope (%)	N/A
N/A	Gutter Lip Ht (in)	N/A	N/A	Gutter X Slope (%)	N/A
N/A	Painted X Walk1?	No	N/A	Painted X Walk2?	No
	X Walk 1 Direction	To N		X Walk 2 Direction	To W
N/A	X Walk 1 Width (in)	N/A	N/A	X Walk 2 Width (in)	N/A
	X Walk 1 Slope (%)	0.3		X Walk 2 Slope (%)	0.2
	X Walk 1 X Slope (%)	0.0		X Walk 2 X Slope (%)	2.1

Remove & Replace Curb Ramp With Two New Directional Ramps or Equivalent.
