# Access Compliance Report

## Public Rights-of-Way

### (Curb Ramps)

Intersection ID: 11070	Main Street: CAMP_GREENE_ST	Cross Street: AMBER_DR	Location: E
ADA ID: 8F7523646A12	Ramp Type: Perpendicular	Initial Pass/Fail: Fail	Overall Compliance: No
		Severity Score: 17.5

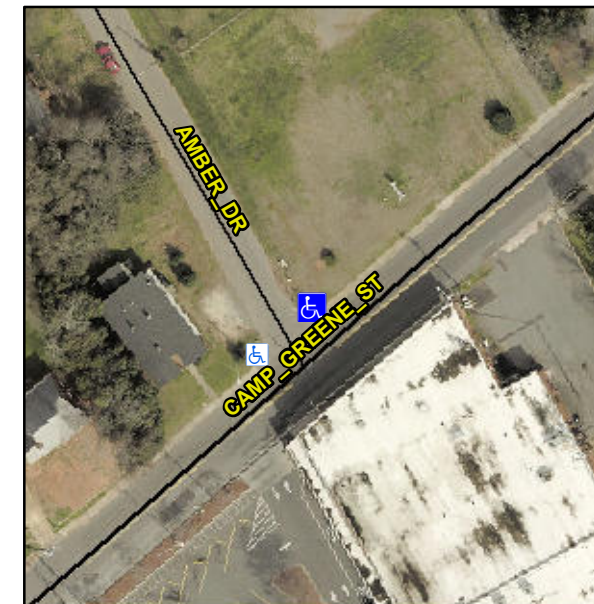
Compliance	Description	Data	Compliance	Description	Data
N/A	Ramp Length (in)	48.0	Yes	Ramp Slope (%)	7.9
No	Ramp Width (in)	34.0	Yes	Ramp XSlope (%)	1.7
N/A	Flare Type LT	N/A	N/A	Flare Type RT	N/A
N/A	Flare Slope LT (%)	N/A	N/A	Flare Slope RT (%)	N/A
N/A	Flare Traversable LT?	N/A	N/A	Flare Traversable RT?	N/A
N/A	Landing Length (in)	N/A	N/A	DWS Provided?	N/A
N/A	Landing Width (in)	N/A	N/A	DWS Contrast?	N/A
N/A	Landing Slope (%)	N/A	N/A	DWS Length (in)	N/A
N/A	Landing X Slope (%)	N/A	N/A	DWS Full Width?	N/A
N/A	Landing Curb? (Y/N)	N/A	N/A	DWS Offset (in)	N/A
N/A	Shared Landing?	N/A			
N/A	Gutter Ponding?	Yes	N/A	Gutter Slope (%)	N/A
N/A	Gutter Lip Ht (in)	N/A	N/A	Gutter X Slope (%)	N/A
N/A	Painted X Walk1?	No	N/A	Painted X Walk2?	N/A
	X Walk 1 Direction	To W		X Walk 2 Direction	N/A
N/A	X Walk 1 Width (in)	N/A	N/A	X Walk 2 Width (in)	N/A
	X Walk 1 Slope (%)	3.2		X Walk 2 Slope (%)	N/A
	X Walk 1 X Slope (%)	3.2		X Walk 2 X Slope (%)	N/A

N/A	Ramp inside XWalk1?	N/A	N/A	Ramp inside XWalk2?	N/A
	Road Slope (%)	N/A	N/A	Clear Space?	N/A
	Road X Slope (%)	N/A	N/A	Clear Space to XWalk (in)	N/A
N/A	Any Obstructions?	N/A	N/A	Storm Grate/Utility Hazard?	N/A
	Obstruction Type			Storm Grate/Utility Type	
		N/A			N/A
		Yes		Surface Condition? (G/P)	Good

**Remove & Replace Entire Ramp.**

**R304.5.1**
