Intersection ID: 52998	Main Street: GRANT_MARTIN_DR	Cross Street: TIMBERBROOK_DR	Location:	S
ADA ID: 8F7C16C65D9E	Ramp Type: Perpendicular	Initial Pass/Fail: Fail	Overall Compliance: No	Severity Score: 8.75

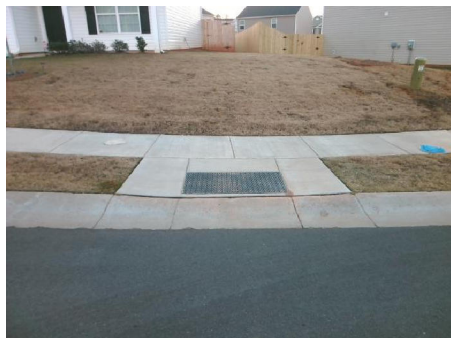
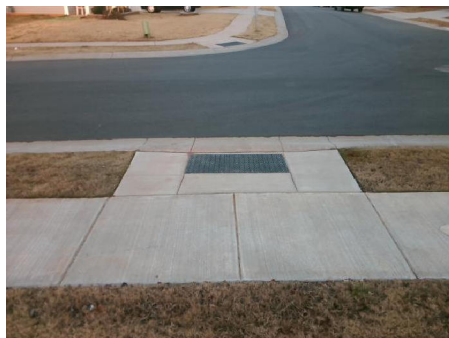
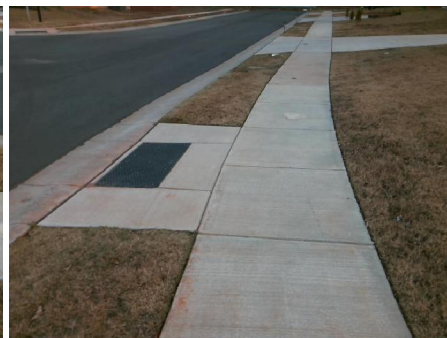
Not Found, R304.5.1

Compliance	Description	Data	Compliance	Description	Data
N/A	Ramp Length (in)	48.0	Yes	Ramp Slope (%)	6.2
No	Ramp Width (in)	47.5	Yes	Ramp XSlope (%)	1.5
N/A	Flare Type LT	N/A	N/A	Flare Type RT	N/A
N/A	Flare Slope LT (%)	N/A	N/A	Flare Slope RT (%)	N/A
N/A	Flare Traversable LT?	N/A	N/A	Flare Traversable RT?	N/A
N/A	Landing Length (in)	N/A	N/A	DWS Provided?	N/A
N/A	Landing Width (in)	N/A	N/A	DWS Contrast?	N/A
N/A	Landing Slope (%)	N/A	N/A	DWS Length (in)	N/A
N/A	Landing X Slope (%)	N/A	N/A	DWS Full Width?	N/A
N/A	Landing Curb? (Y/N)	N/A	N/A	DWS Offset (in)	N/A
N/A	Shared Landing?	N/A			
N/A	Gutter Ponding?	N/A	N/A	Gutter Slope (%)	N/A
N/A	Gutter Lip Ht (in)	N/A	N/A	Gutter X Slope (%)	N/A
N/A	Painted X Walk1?	No	N/A	Painted X Walk2?	N/A
	X Walk 1 Direction	To NW		X Walk 2 Direction	N/A
N/A	X Walk 1 Width (in)	N/A	N/A	X Walk 2 Width (in)	N/A
	X Walk 1 Slope (%)	5.7		X Walk 2 Slope (%)	N/A
	X Walk 1 X Slope (%)	2.5		X Walk 2 X Slope (%)	N/A

N/A	Ramp inside XWalk1?	N/A	N/A	Ramp inside XWalk2?	N/A
	Road Slope (%)	N/A	N/A	Clear Space?	N/A
	Road X Slope (%)	N/A	N/A	Clear Space to XWalk (in)	N/A
N/A	Any Obstructions?	N/A	N/A	Storm Grate/Utility Hazard?	N/A
	Obstruction Type			Storm Grate/Utility Type	
		N/A			N/A
			Yes	Surface Condition? (G/P)	Good

Remove & Replace Entire Ramp.
