Access Compliance Report

Public Rights-of-Way

(Curb Ramps)

Intersection ID: 7826	Main Street: BROOKSHIRE_BV	Cross Street: DAKOTA_ST	Location: NW
ADA ID: 8F7D98FAD6EC	Ramp Type: Para	Initial Pass/Fail: Fail	Overall Compliance: No
			Severity Score: 13.75

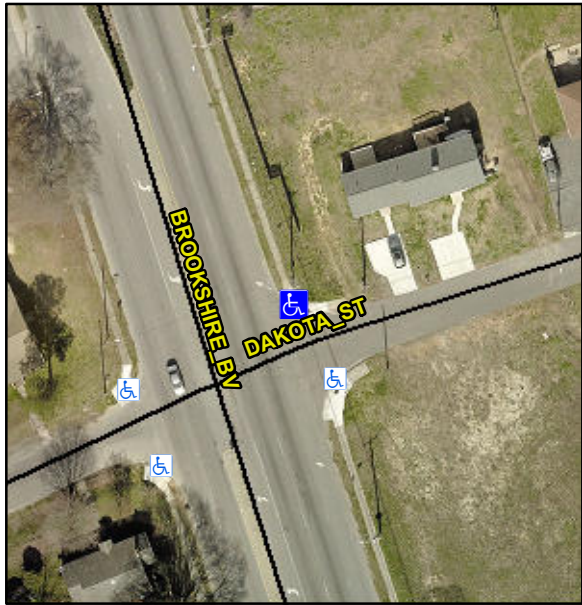
Possible Solutions:		Compliance	Description	Data	Compliance	Description	Data
	Remove & Replace Entire Ramp.		N/A	Ramp Length LT (in)	53.0	N/A	Ramp Length RT (in)	65.0
			Yes	Ramp Width LT (in)	54.0	Yes	Ramp Width RT (in)	54.0
			No	Ramp Slope LT (%)	10.9	Yes	Ramp Slope RT (%)	0.7
			No	Ramp XSlope LT (%)	2.4	Yes	Ramp XSlope RT (%)	1.5
			N/A	Landing Length (in)	N/A	N/A	DWS Provided?	N/A
			N/A	Landing Width (in)	N/A	N/A	DWS Contrast?	N/A
			N/A	Landing Slope (%)	N/A	N/A	DWS Length (in)	N/A
			N/A	Landing X Slope (%)	N/A	N/A	DWS Full Width?	N/A
			N/A	Landing Curb? (Y/N)	N/A	N/A	DWS Offset (in)	N/A
Surveyor Notes:		N/A	Shared Landing?	N/A				
RT RP < 5%		N/A	Gutter Ponding?	N/A	N/A	Gutter Slope (%)	N/A	N/A
PROW/ADA:		N/A	Gutter Lip Ht (in)	N/A	N/A	Gutter X Slope (%)	N/A	N/A
R304.3.2, R304.5.3		N/A	Painted X Walk1?	No	N/A	Painted X Walk2?	N/A	N/A

X Walk 1 Direction	To SE		X Walk 2 Direction	N/A	N/A
		N/A	X Walk 1 Width (in)	N/A	N/A	X Walk 2 Width (in)	N/A	N/A
			X Walk 1 Slope (%)	4.9		X Walk 2 Slope (%)	N/A	N/A
			X Walk 1 X Slope (%)	6.3		X Walk 2 X Slope (%)	N/A	N/A
		N/A	Ramp inside XWalk1?	N/A	N/A	Ramp inside XWalk2?	N/A	N/A
			Road Slope (%)	N/A	N/A	Clear Space?	N/A	N/A
			Road X Slope (%)	N/A	N/A	Clear Space to XWalk (in)	N/A	N/A
		N/A	Any Obstructions?	N/A	N/A	Storm Grate/Utility Hazard?	N/A	N/A
			Obstruction Type			Storm Grate/Utility Type		
Total Cost:		\$ 1600.00			N/A			N/A
						Yes	Surface Condition? (G/P)	Good
						N/A	Curb Slope (%)	25.1
