Access Compliance Report Public Rights-of-Way (Curb Ramps)

Intersection ID: 17673	Main Street: MONROE RD	Cross Street: OLD_POST_RD	Location: NW
ADA ID: 8F83FEB13236	Ramp Type: Perpendicular Diagonal	Initial Pass/Fail: Pass	Overall Compliance: No Severity Score: 22.75

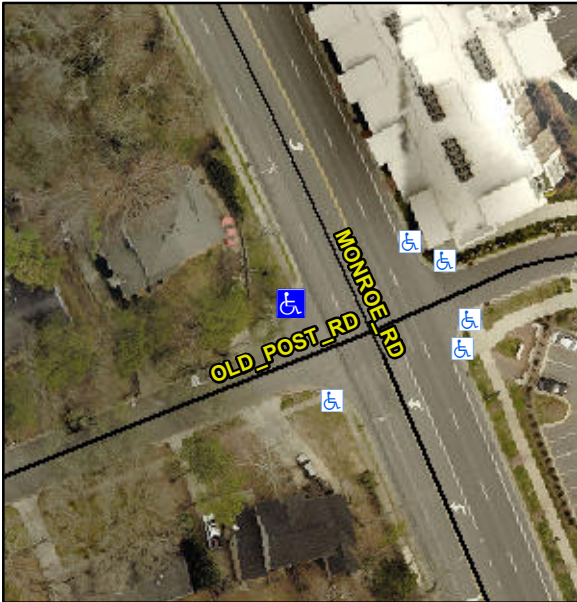
Not Found, R304.5.3, R304.2.1, R304.2.2-Perp, R304.3.2-Para, R305.2, R302.7.2, R304.5.4

Compliance	Description	Data	Compliance	Description	Data
N/A	Ramp Length (in)	47.5	Yes	Ramp Slope (%)	5.3
Yes	Ramp Width (in)	48.0	No	Ramp XSlope (%)	4.0
N/A	Flare Type LT	Sloped	N/A	Flare Type RT	N/A
N/A	Flare Slope LT (%)	2.8	Yes	Flare Slope RT (%)	5.6
N/A	Flare Traversable LT?	Yes	N/A	Flare Traversable RT?	Yes
No	Landing Length (in)	N/A	Yes	DWS Provided?	Yes
No	Landing Width (in)	N/A	Yes	DWS Contrast?	Yes
No	Landing Slope (%)	N/A	Yes	DWS Length (in)	24.5
No	Landing X Slope (%)	N/A	Yes	DWS Full Width?	Yes
N/A	Landing Curb? (Y/N)	No	No	DWS Offset (in)	3.0
N/A	Shared Landing?	N/A			
Yes	Gutter Ponding?	No	No	Gutter Slope (%)	5.5
No	Gutter Lip Ht (in)	0.5	Yes	Gutter X Slope (%)	1.4
N/A	Painted X Walk1?	No	N/A	Painted X Walk2?	No
	X Walk 1 Direction	To S		X Walk 2 Direction	To E
N/A	X Walk 1 Width (in)	N/A	N/A	X Walk 2 Width (in)	N/A
	X Walk 1 Slope (%)	2.0		X Walk 2 Slope (%)	5.0
	X Walk 1 X Slope (%)	5.3		X Walk 2 X Slope (%)	2.3

N/A	Ramp inside XWalk1?	N/A	N/A	Ramp inside XWalk2?	N/A
	Road Slope (%)	3.4	N/A	Clear Space?	Yes
	Road X Slope (%)	6.2	N/A	Clear Space to XWalk (in)	N/A
Yes	Any Obstructions?	No	Yes	Storm Grate/Utility Hazard?	No
	Obstruction Type			Storm Grate/Utility Type	
			N/A		N/A
			Yes	Surface Condition? (G/P)	Good

Possible Solutions:
Remove & Replace Curb Ramp With Two New Directional Ramps or Equivalent. Remove & Replace Gutter.
