Access Compliance Report

Public Rights-of-Way

(Curb Ramps)

Intersection ID: 48642	Main Street: BROCK_RN	Cross Street: EASTFIELD_VILLAGE_LN	Location: W
ADA ID: 8F8F26568EDB	Ramp Type: Perpendicular	Initial Pass/Fail: Fail	Overall Compliance: No
		Severity Score: 8.75

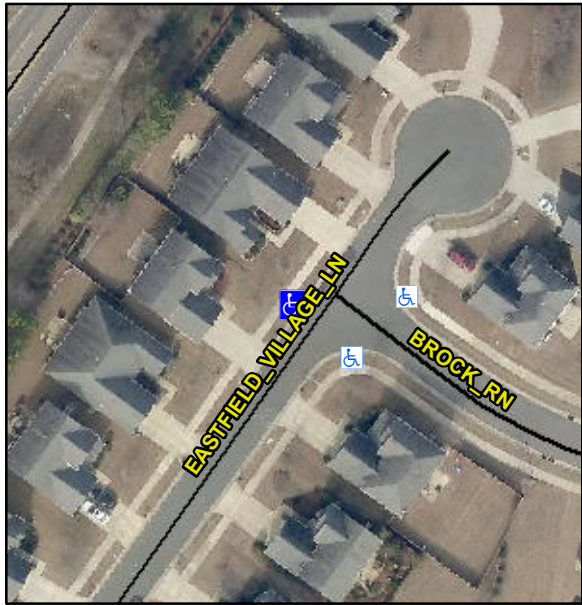
Possible Solutions:		Compliance	Description	Data	Compliance	Description	Data
	Remove & Replace Entire Ramp.		N/A	Ramp Length (in)	70.0	Yes	Ramp Slope (%)	7.8
			No	Ramp Width (in)	47.0	Yes	Ramp XSlope (%)	1.4
			N/A	Flare Type LT	N/A	N/A	Flare Type RT	N/A
			N/A	Flare Slope LT (%)	N/A	N/A	Flare Slope RT (%)	N/A
			N/A	Flare Traversable LT?	N/A	N/A	Flare Traversable RT?	N/A
			N/A	Landing Length (in)	N/A	N/A	DWS Provided?	N/A
			N/A	Landing Width (in)	N/A	N/A	DWS Contrast?	N/A
			N/A	Landing Slope (%)	N/A	N/A	DWS Length (in)	N/A
			N/A	Landing X Slope (%)	N/A	N/A	DWS Full Width?	N/A
Surveyor Notes:		N/A	N/A	Landing Curb? (Y/N)	N/A	N/A	DWS Offset (in)	N/A
PROW/ADA:		Not Found, R304.5.1	N/A	Shared Landing?	N/A			
			N/A	Gutter Ponding?	N/A	N/A	Gutter Slope (%)	N/A
			N/A	Gutter Lip Ht (in)	N/A	N/A	Gutter X Slope (%)	N/A
