## Access Compliance Report Public Rights-of-Way (Curb Ramps)

Intersection ID: N/A Main Street: EASTWAY\_DR Cross Street: N/A Location: E

ADA ID: 8F93713E77C2 Ramp Type: MedianPerp Initial Pass/Fail: Fail Overall Compliance: No Severity Score: 13.75

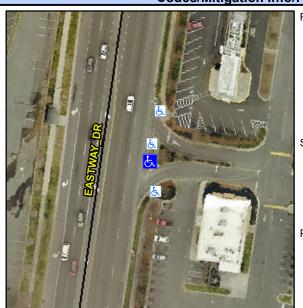
Field Measurements/Component Compliance						
Comp	liance Description	Data	Comp	liance	Description	Data
N/A	Ramp Length (in)	47.0	No	Ramp	Slope (%)	9.0
Yes	Ramp Width (in)	53.0	No	Ramp	XSlope (%)	3.7
N/A	Flare Type LT	N/A	N/A	Flare	Type RT	N/A
N/A	Flare Slope LT (%)	N/A	N/A	Flare	Slope RT (%)	N/A
N/A	Flare Traversable LT?	N/A	N/A	Flare	Traversable RT?	N/A
N/A	Landing Length (in)	N/A	N/A	DWS	Provided?	N/A
N/A	Landing Width (in)	N/A	N/A	DWS	Contrast?	N/A
N/A	Landing Slope (%)	N/A	N/A	DWS	Length (in)	N/A
N/A	Landing X Slope (%)	N/A	N/A	DWS	Full Width?	N/A
N/A	Landing Curb? (Y/N)	N/A	N/A	DWS	Offset (in)	N/A
N/A	Shared Landing?	N/A				
N/A	Gutter Ponding?	N/A	N/A	Gutte	r Slope (%)	N/A
N/A	Gutter Lip Ht (in)	N/A	N/A	Gutte	r X Slope (%)	N/A
N/A	Painted X Walk1?	No	N/A	Paint	ed X Walk2?	N/A
	X Walk 1 Direction	To S		X Wa	lk 2 Direction	N/A
N/A	X Walk 1 Width (in)	N/A	N/A	X Wa	lk 2 Width (in)	N/A
	X Walk 1 Slope (%)	0.1		X Wa	lk 2 Slope (%)	N/A

X Walk 1 X Slope (%)	3.5		X Wa	lk 2 X Slope (%)	N/A
N/A	Ramp inside XWalk1?	N/A	N/A	Ram	inside XWalk2?	N/A
	Road Slope (%)	N/A	N/A	Clear	Space?	N/A
	Road X Slope (%)	N/A	N/A	Clear	Space to XWalk (in)	N/A
N/A	Any Obstructions?	N/A	N/A	Storn	n Grate/Utility Hazard?	N/A
	Obstruction Type			Storn	n Grate/Utility Type	
		N/A				N/A
			Yes	Surfa	ce Condition? (G/P)	Good

-		
	Possible Solutions:	9
	Remove & Replace Entire Ramp.	N
	·	Υ
		N
		N
ı		N
ı		N
1	Surveyor Notes:	N
	N/A	N
3		N
		N
2000		N
	PROW/ADA:	N
	Not Found, R304.2.2, R304.5.3	N
		N
		N
		N
