Access Compliance Report

Public Rights-of-Way

(Curb Ramps)

Intersection ID: 24333	Main Street: BIRNEN_DR	Cross Street: GLISSON_CT	Location: NW
ADA ID: 8FA843CEAAF6	Ramp Type: PerpDiag	Initial Pass/Fail: Fail	Overall Compliance: No
		Severity Score: 8.75

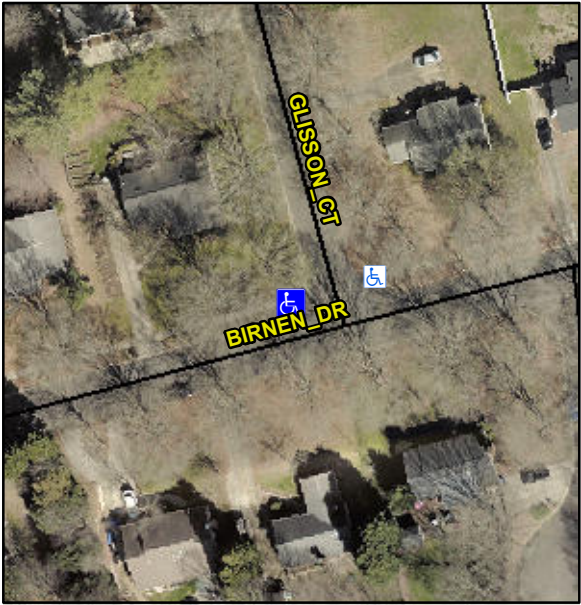
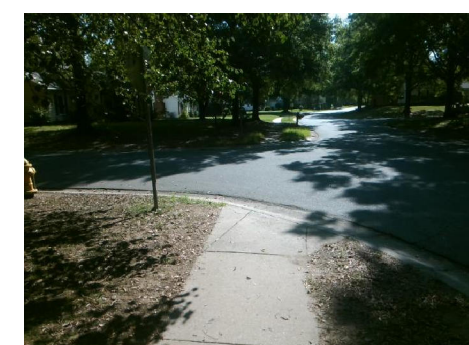
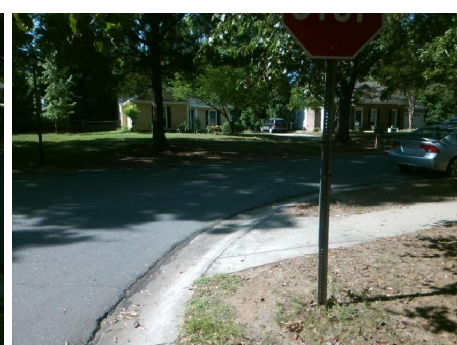
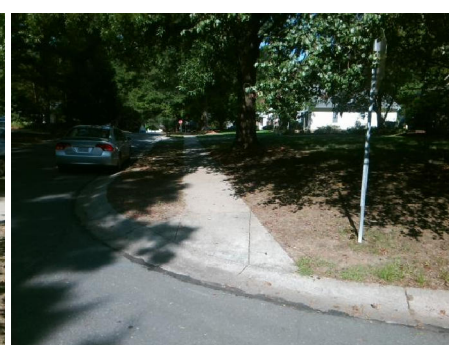
Possible Solutions:		Compliance	Description	Data
	Remove & Replace Curb Ramp With Two New Directional Ramps or Equivalent.		N/A	Ramp Length (in)	49.0
			No	Ramp Width (in)	42.0
			N/A	Flare Type LT	N/A
			N/A	Flare Slope LT (%)	N/A
			N/A	Flare Traversable LT?	N/A
			N/A	Landing Length (in)	N/A
			N/A	Landing Width (in)	N/A
			N/A	Landing Slope (%)	N/A
			N/A	Landing X Slope (%)	N/A
<p>Surveyor Notes:</p> <p>N/A</p> <p>PROW/ADA:</p> <p>Not Found, R304.5.1</p>			N/A	Flare Type RT	N/A
			N/A	Flare Slope RT (%)	N/A
			N/A	Flare Traversable RT?	N/A
			N/A	DWS Provided?	N/A
			N/A	DWS Contrast?	N/A
			N/A	DWS Length (in)	N/A
			N/A	DWS Full Width?	N/A
			N/A	DWS Offset (in)	N/A
			N/A	Gutter Ponding?	N/A
			N/A	Gutter Lip Ht (in)	N/A
			N/A	Painted X Walk1?	No
				X Walk 1 Direction	To S
			N/A	X Walk 1 Width (in)	N/A
				X Walk 1 Slope (%)	2.0

X Walk 1 X Slope (%)	2.1
			N/A	Ramp inside XWalk1?	N/A
				Road Slope (%)	2.1
				Road X Slope (%)	2.6
			N/A	Any Obstructions?	N/A
				Obstruction Type	
Total Cost:		\$ 3200.00			
			N/A		N/A
			Yes	Surface Condition? (G/P)	Good
