Access Compliance Report

Public Rights-of-Way

(Curb Ramps)

Intersection ID: 46533	Main Street: GLEN HOPE LN	Cross Street: SUTTONVIEW DR	Location: E
ADA ID: 8FAA81EF73E4	Ramp Type: PerpDiag	Initial Pass/Fail: Fail	Overall Compliance: No
		Severity Score: 17.5

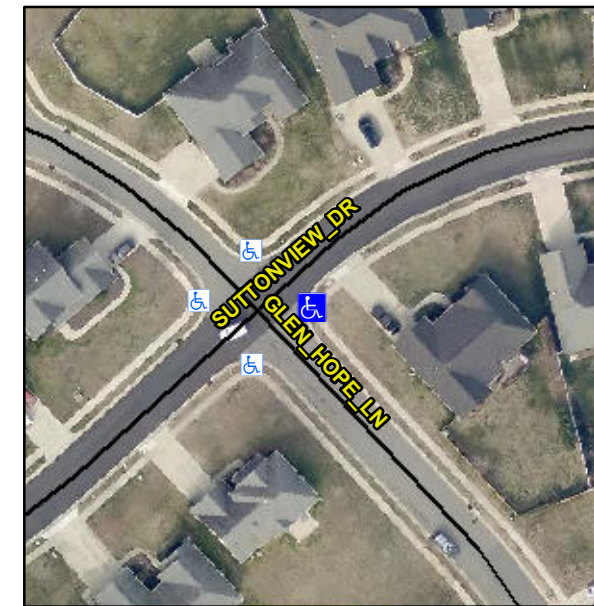
Compliance	Description	Data	Compliance	Description	Data
N/A	Ramp Length (in)	48.0	Yes	Ramp Slope (%)	5.9
No	Ramp Width (in)	33.0	Yes	Ramp XSlope (%)	1.7
N/A	Flare Type LT	N/A	N/A	Flare Type RT	N/A
N/A	Flare Slope LT (%)	N/A	N/A	Flare Slope RT (%)	N/A
N/A	Flare Traversable LT?	N/A	N/A	Flare Traversable RT?	N/A
N/A	Landing Length (in)	N/A	N/A	DWS Provided?	N/A
N/A	Landing Width (in)	N/A	N/A	DWS Contrast?	N/A
N/A	Landing Slope (%)	N/A	N/A	DWS Length (in)	N/A
N/A	Landing X Slope (%)	N/A	N/A	DWS Full Width?	N/A
N/A	Landing Curb? (Y/N)	N/A	N/A	DWS Offset (in)	N/A
N/A	Shared Landing?	N/A			
N/A	Gutter Ponding?	N/A	N/A	Gutter Slope (%)	N/A
N/A	Gutter Lip Ht (in)	N/A	N/A	Gutter X Slope (%)	N/A
N/A	Painted X Walk1?	No	N/A	Painted X Walk2?	No
	X Walk 1 Direction	To NW		X Walk 2 Direction	To SW
N/A	X Walk 1 Width (in)	N/A	N/A	X Walk 2 Width (in)	N/A
	X Walk 1 Slope (%)	2.8		X Walk 2 Slope (%)	3.8
	X Walk 1 X Slope (%)	6.3		X Walk 2 X Slope (%)	1.8

N/A	Ramp inside XWalk1?	N/A	N/A	Ramp inside XWalk2?	N/A
	Road Slope (%)	1.8	N/A	Clear Space?	N/A
	Road X Slope (%)	7.4	N/A	Clear Space to XWalk (in)	N/A
N/A	Any Obstructions?	N/A	N/A	Storm Grate/Utility Hazard?	N/A
	Obstruction Type			Storm Grate/Utility Type	
		N/A			N/A
			Yes	Surface Condition? (G/P)	Good

Possible Solutions:

Remove & Replace Curb Ramp With Two New Directional Ramps or Equivalent.

R304.5.1
