Access Compliance Report

Public Rights-of-Way

(Curb Ramps)

Intersection ID: 5889	Main Street: UNIVERSITY_CITY_BV	Cross Street: SUTHER_RD	Location:	S
ADA ID: 8FACB604FA84	Ramp Type: Perp	Initial Pass/Fail: Fail	Overall Compliance: No	Severity Score: 10
Codes/Mitigation Info/Possible Solution		Field Measurements/Component Compliance

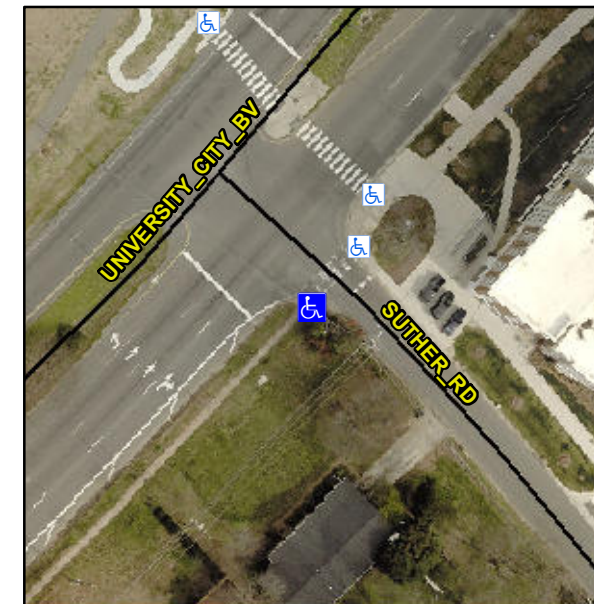
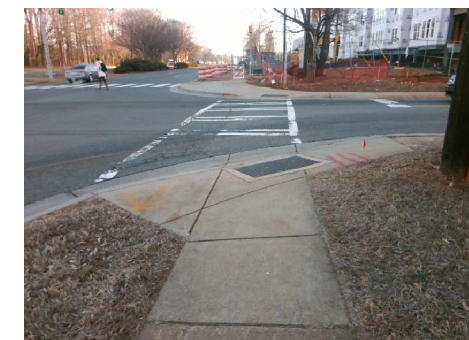
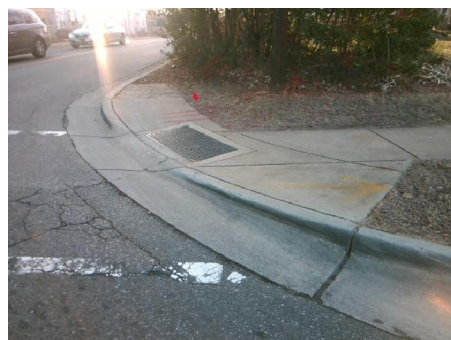
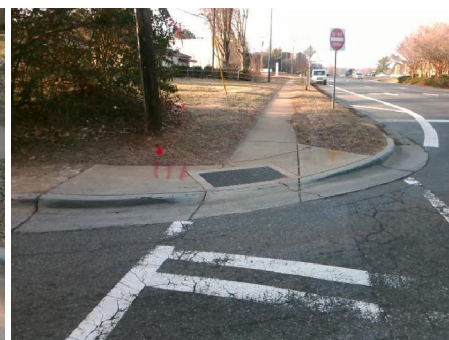
Not Found, R304.5.1, R304.5.3

Compliance	Description	Data	Compliance	Description	Data
N/A	Ramp Length (in)	45.5	Yes	Ramp Slope (%)	5.8
No	Ramp Width (in)	47.5	No	Ramp XSlope (%)	2.5
N/A	Flare Type LT	N/A	N/A	Flare Type RT	N/A
N/A	Flare Slope LT (%)	N/A	N/A	Flare Slope RT (%)	N/A
N/A	Flare Traversable LT?	N/A	N/A	Flare Traversable RT?	N/A
N/A	Landing Length (in)	N/A	N/A	DWS Provided?	N/A
N/A	Landing Width (in)	N/A	N/A	DWS Contrast?	N/A
N/A	Landing Slope (%)	N/A	N/A	DWS Length (in)	N/A
N/A	Landing X Slope (%)	N/A	N/A	DWS Full Width?	N/A
N/A	Landing Curb? (Y/N)	N/A	N/A	DWS Offset (in)	N/A
N/A	Shared Landing?	N/A			
N/A	Gutter Ponding?	N/A	N/A	Gutter Slope (%)	N/A
N/A	Gutter Lip Ht (in)	N/A	N/A	Gutter X Slope (%)	N/A
N/A	Painted X Walk1?	Yes	N/A	Painted X Walk2?	N/A
	X Walk 1 Direction	To NE		X Walk 2 Direction	N/A
N/A	X Walk 1 Width (in)	103.0	N/A	X Walk 2 Width (in)	N/A
	X Walk 1 Slope (%)	1.9		X Walk 2 Slope (%)	N/A
	X Walk 1 X Slope (%)	0.7		X Walk 2 X Slope (%)	N/A

N/A	Ramp inside XWalk1?	Yes	N/A	Ramp inside XWalk2?	N/A
	Road Slope (%)	N/A	N/A	Clear Space?	N/A
	Road X Slope (%)	N/A	N/A	Clear Space to XWalk (in)	N/A
N/A	Any Obstructions?	N/A	N/A	Storm Grate/Utility Hazard?	N/A
	Obstruction Type			Storm Grate/Utility Type	
		N/A			N/A
			Yes	Surface Condition? (G/P)	Good

Possible Solutions:

Remove & Replace Entire Ramp.
