Access Compliance Report Public Rights-of-Way (Curb Ramps)

Intersection ID: 46784 Main Street: MILLSTREAM_RIDGE_DR Cross Street: DOMINION_VILLAGE_DR Location: W

ADA ID: 8FAE50BF0A68 Ramp Type: BlendTrans1 Initial Pass/Fail: Fail Overall Compliance: No Severity Score: 21.25

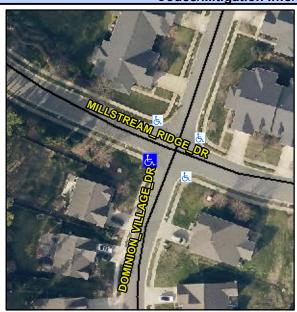
NO LT FL

Not Found, R304.5.1, R304.5.3

Comp	liance Description	Data	Comp	liance Description	Data
	N/A	Ramp Length (in)	50.0	Yes	BlendTrans Slope (%)	0.9
	No	Ramp Width (in)	37.0	No	BlendTrans XSlope (%)	5.4
	N/A	Flare Type LT	N/A	N/A	Flare Type RT	N/A
	N/A	Flare Slope LT (%)	N/A	N/A	Flare Slope RT (%)	N/A
	N/A	Flare Traversable LT?	N/A	N/A	Flare Traversable RT?	N/A
	N/A	Landing Length (in)	N/A	N/A	DWS Provided?	N/A
	N/A	Landing Width (in)	N/A	N/A	DWS Contrast?	N/A
	N/A	Landing Slope (%)	N/A	N/A	DWS Length (in)	N/A
	N/A	Landing X Slope (%)	N/A	N/A	DWS Full Width?	N/A
	N/A	Landing Curb? (Y/N)	N/A	N/A	DWS Offset (in)	N/A
	N/A	Shared Landing?	N/A			
	N/A	Gutter Ponding?	N/A	N/A	Gutter Slope (%)	N/A
	N/A	Gutter Lip Ht (in)	N/A	N/A	Gutter X Slope (%)	N/A
	N/A	Painted X Walk1?	No	N/A	Painted X Walk2?	No
		X Walk 1 Direction	To SE		X Walk 2 Direction	To NE
		X Walk 1 Width (in)	N/A		X Walk 2 Width (in)	N/A
		X Walk 1 Slope (%)	3.8		X Walk 2 Slope (%)	7.2

X Walk 1 X Slope (%)	4.5		X Walk 2 X Slope (%)	7.5
	N/A	Ramp inside XWalk1?	N/A	N/A	Ramp inside XWalk2?	N/A
		Road Slope (%)	6.6		Clear Space?	N/A
		Road X Slope (%)	0.1	N/A	Clear Space to XWalk (in)	N/A
	N/A	Any Obstructions?	N/A	N/A	Storm Grate/Utility Hazard?	N/A
		Obstruction Type			Storm Grate/Utility Type	
			N/A			N/A
				Yes	Surface Condition? (G/P)	Good
30	W W			No	Curb Slope (%)	19.7

Remove & Replace Curb Ramp With Two New Directional Ramps or Equivalent.
