Access Compliance Report

Public Rights-of-Way

(Curb Ramps)

Intersection ID: 10026412	Main Street: FARM_POND_LN	Cross Street: N/A	Location: SE
ADA ID: 8FB68594D5D1	Ramp Type: BlendTrans2	Initial Pass/Fail: Fail	Overall Compliance: No
		Severity Score: 12.5

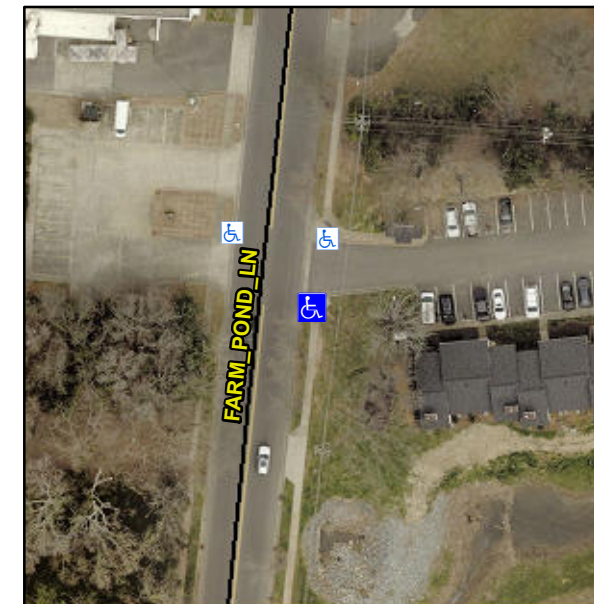
Not Found, R304.5.3

Compliance	Description	Data	Compliance	Description	Data
N/A	Ramp Length (in)	58.0	Yes	BlendTrans Slope (%)	1.9
Yes	Ramp Width (in)	48.0	No	BlendTrans XSlope (%)	6.7
N/A	Flare Type LT	N/A	N/A	Flare Type RT	N/A
N/A	Flare Slope LT (%)	N/A	N/A	Flare Slope RT (%)	N/A
N/A	Flare Traversable LT?	N/A	N/A	Flare Traversable RT?	N/A
N/A	Landing Length (in)	N/A	N/A	DWS Provided?	N/A
N/A	Landing Width (in)	N/A	N/A	DWS Contrast?	N/A
N/A	Landing Slope (%)	N/A	N/A	DWS Length (in)	N/A
N/A	Landing X Slope (%)	N/A	N/A	DWS Full Width?	N/A
N/A	Landing Curb? (Y/N)	N/A	N/A	DWS Offset (in)	N/A
N/A	Shared Landing?	N/A			
N/A	Gutter Ponding?	N/A	N/A	Gutter Slope (%)	N/A
N/A	Gutter Lip Ht (in)	N/A	N/A	Gutter X Slope (%)	N/A
N/A	Painted X Walk1?	No	N/A	Painted X Walk2?	No
	X Walk 1 Direction	To N		X Walk 2 Direction	To W
	X Walk 1 Width (in)	N/A		X Walk 2 Width (in)	N/A
	X Walk 1 Slope (%)	3.0		X Walk 2 Slope (%)	2.6
	X Walk 1 X Slope (%)	2.7		X Walk 2 X Slope (%)	3.8

N/A	Ramp inside XWalk1?	N/A	N/A	Ramp inside XWalk2?	N/A
	Road Slope (%)	3.3		Clear Space?	N/A
	Road X Slope (%)	2.5	N/A	Clear Space to XWalk (in)	N/A
N/A	Any Obstructions?	N/A	N/A	Storm Grate/Utility Hazard?	N/A
	Obstruction Type			Storm Grate/Utility Type	
		N/A			N/A
			Yes	Surface Condition? (G/P)	Good
			No	Curb Slope (%)	11.2

Remove & Replace Curb Ramp With Two New Directional Ramps or Equivalent.
