Access Compliance Report Public Rights-of-Way (Curb Ramps)

Intersection ID: 29740 Main Street: KNIGHT CASTLE DR **Cross Street: MORGANA CT** Location: NE Ramp Type: PerpDiag Initial Pass/Fail: Pass **Overall Compliance: No Severity Score:** 22.5 **ADA ID: 8FB6DA43E317**

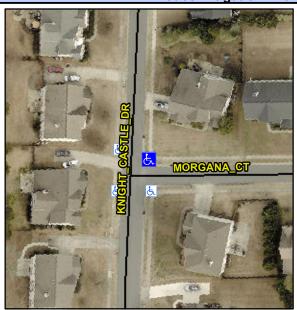
Street 1 Name Stop Condition-Street 2 Street 2 Name Stop Condition-Street 1 KNIGHT CASTLE DR None **MORGANA CT** StopSign Remove & Replace Curb Ramp With Two New Directional Ramps or Equivalent. Remove & Replace Gutter.

Con	npliance Description	Data		pliance Description	Data
N/A	Ramp Length (in)	96.0	Yes	Ramp Slope (%)	6.7
Yes	Ramp Width (in)	48.0	Yes	Ramp XSlope (%)	2.0
N/A	Flare Type LT	Sloped	N/A	Flare Type RT	N/A
N/A	Flare Slope LT (%)	2.5	N/A	Flare Slope RT (%)	0.4
N/A	Flare Traversable LT?	No	N/A	Flare Traversable RT?	No
No	Landing Length (in)	N/A	Yes	DWS Provided?	Yes
No	Landing Width (in)	N/A	Yes	DWS Contrast?	Yes
No	Landing Slope (%)	N/A	Yes	DWS Length (in)	24.0
No	Landing X Slope (%)	N/A	Yes	DWS Full Width?	Yes
N/A	Landing Curb? (Y/N)	No	No	DWS Offset (in)	3.0
N/A	Shared Landing?	No			
Yes	Gutter Ponding?	No	No	Gutter Slope (%)	8.4
No	Gutter Lip Ht (in)	0.5	Yes	Gutter X Slope (%)	1.6
N/A	Painted X Walk1?	No	N/A	Painted X Walk2?	No
	X Walk 1 Direction	To NW		X Walk 2 Direction	To S
N/A	X Walk 1 Width (in)	N/A	N/A	X Walk 2 Width (in)	N/A
	X Walk 1 Slope (%)	0.7		X Walk 2 Slope (%)	0.8
	X Walk 1 X Slope (%)	0.4		X Walk 2 X Slope (%)	0.2

N/A	Ramp inside XWalk1?	N/A	N/A	Ramp inside XWalk2?	N/A
	Road Slope (%)	0.1	N/A	Clear Space?	Yes
	Road X Slope (%)	0.6	N/A	Clear Space to XWalk (in)	N/A
Yes	Any Obstructions?	No	Yes	Storm Grate/Utility Hazard?	No
	Obstruction Type			Storm Grate/Utility Type	
		N/A			N/A
			Yes	Surface Condition? (G/P)	Good

R304.2.1, R304.2.2-Perp, R304.3.2-Para, R304.5.3, R305.2, R302.7.2, R304.5.4

Total Cost: 3950.00
