Access Compliance Report

Public Rights-of-Way

(Curb Ramps)

Intersection ID: 31888	Main Street: CENTERLINE_DR	Cross Street: LAMOILLE_LN	Location: SE
ADA ID: 8FBA5A1F7B10	Ramp Type: BlendTrans1	Initial Pass/Fail: Fail	Overall Compliance: No
Severity Score: 10			
Codes/Mitigation Info/Possible Solution		Field Measurements/Component Compliance

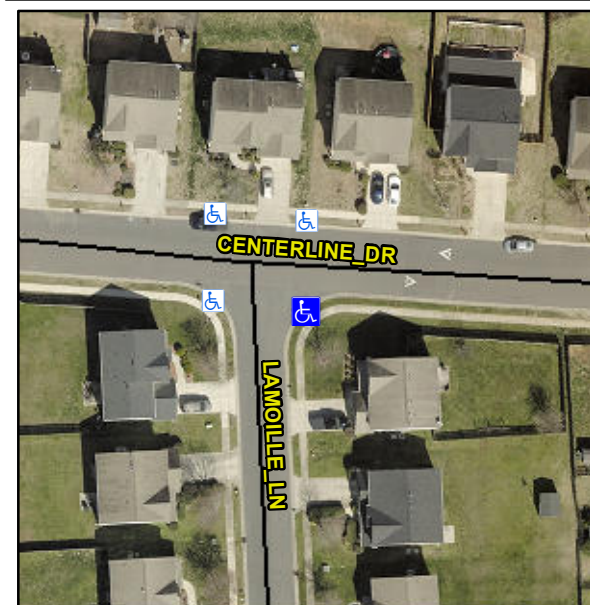
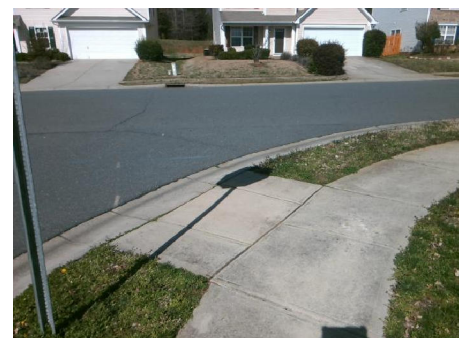
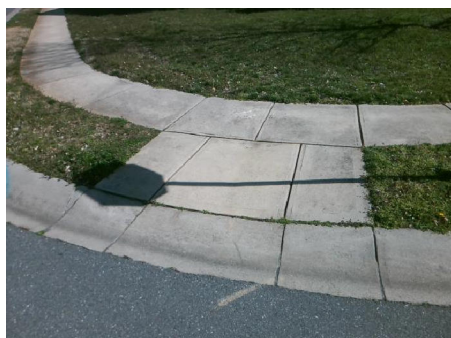
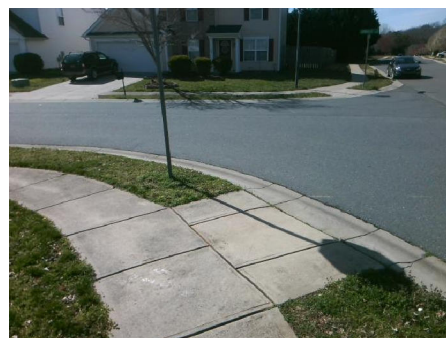
Not Found, R304.5.1, R304.5.3

Compliance	Description	Data	Compliance	Description	Data
N/A	Ramp Length (in)	49.0	Yes	BlendTrans Slope (%)	3.8
No	Ramp Width (in)	39.0	No	BlendTrans XSlope (%)	3.1
N/A	Flare Type LT	N/A	N/A	Flare Type RT	N/A
N/A	Flare Slope LT (%)	N/A	N/A	Flare Slope RT (%)	N/A
N/A	Flare Traversable LT?	N/A	N/A	Flare Traversable RT?	N/A
N/A	Landing Length (in)	N/A	N/A	DWS Provided?	N/A
N/A	Landing Width (in)	N/A	N/A	DWS Contrast?	N/A
N/A	Landing Slope (%)	N/A	N/A	DWS Length (in)	N/A
N/A	Landing X Slope (%)	N/A	N/A	DWS Full Width?	N/A
N/A	Landing Curb? (Y/N)	N/A	N/A	DWS Offset (in)	N/A
N/A	Shared Landing?	N/A			
N/A	Gutter Ponding?	N/A	N/A	Gutter Slope (%)	N/A
N/A	Gutter Lip Ht (in)	N/A	N/A	Gutter X Slope (%)	N/A
N/A	Painted X Walk1?	No	N/A	Painted X Walk2?	No
	X Walk 1 Direction	To N		X Walk 2 Direction	To W
	X Walk 1 Width (in)	N/A		X Walk 2 Width (in)	N/A
	X Walk 1 Slope (%)	4.0		X Walk 2 Slope (%)	0.1
	X Walk 1 X Slope (%)	0.6		X Walk 2 X Slope (%)	3.3

N/A	Ramp inside XWalk1?	N/A	N/A	Ramp inside XWalk2?	N/A
	Road Slope (%)	2.3		Clear Space?	N/A
	Road X Slope (%)	3.1	N/A	Clear Space to XWalk (in)	N/A
N/A	Any Obstructions?	N/A	N/A	Storm Grate/Utility Hazard?	N/A
	Obstruction Type			Storm Grate/Utility Type	
		N/A			N/A
			Yes	Surface Condition? (G/P)	Good
			No	Curb Slope (%)	6.3

Remove & Replace Curb Ramp With Two New Directional Ramps or Equivalent.
