Access Compliance Report

Public Rights-of-Way

(Curb Ramps)

Intersection ID: 49796	Main Street: TRISTAN_CT	Cross Street: ATKINS_RIDGE_DR	Location: E
ADA ID: 8FBD6A04B4AB	Ramp Type: PerpDiag	Initial Pass/Fail: Fail	Overall Compliance: No
Severity Score: 0			
Codes/Mitigation Info/Possible Solution		Field Measurements/Component Compliance

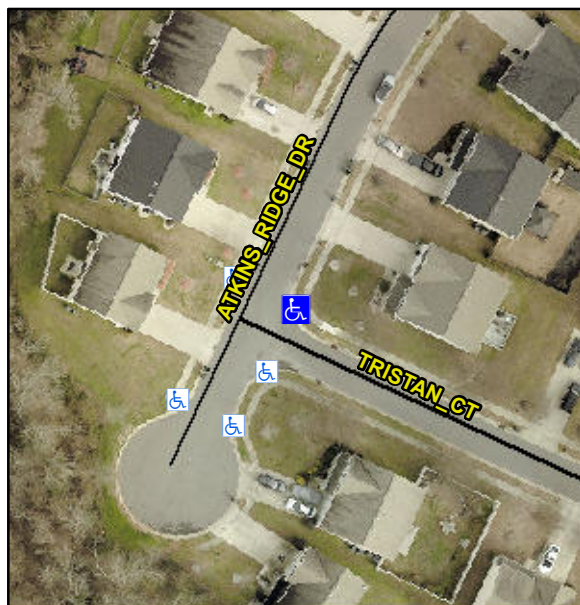
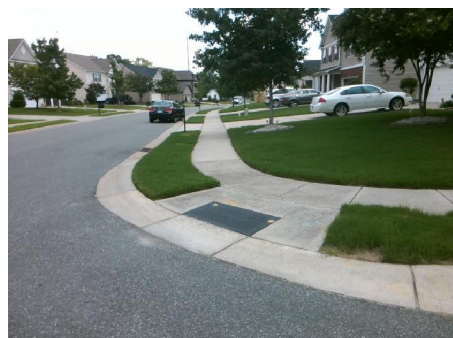
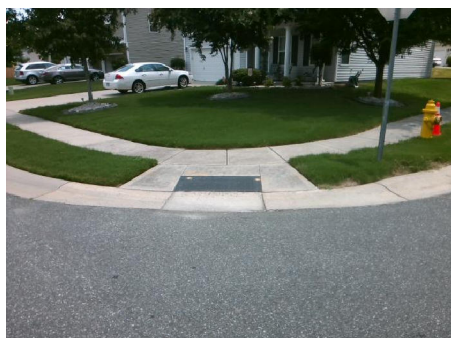
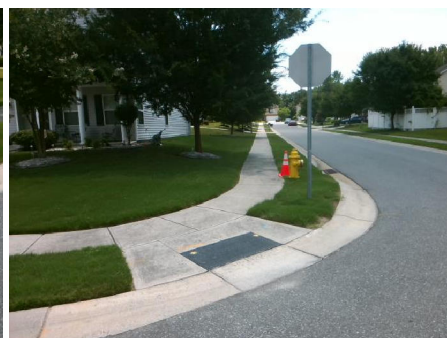
Compliance	Description	Data	Compliance	Description	Data
N/A	Ramp Length (in)	47.0	Yes	Ramp Slope (%)	5.3
Yes	Ramp Width (in)	48.1	Yes	Ramp XSlope (%)	1.3
N/A	Flare Type LT	N/A	N/A	Flare Type RT	N/A
N/A	Flare Slope LT (%)	N/A	N/A	Flare Slope RT (%)	N/A
N/A	Flare Traversable LT?	N/A	N/A	Flare Traversable RT?	N/A
N/A	Landing Length (in)	N/A	N/A	DWS Provided?	N/A
N/A	Landing Width (in)	N/A	N/A	DWS Contrast?	N/A
N/A	Landing Slope (%)	N/A	N/A	DWS Length (in)	N/A
N/A	Landing X Slope (%)	N/A	N/A	DWS Full Width?	N/A
N/A	Landing Curb? (Y/N)	N/A	N/A	DWS Offset (in)	N/A
N/A	Shared Landing?	N/A			
N/A	Gutter Ponding?	N/A	N/A	Gutter Slope (%)	N/A
N/A	Gutter Lip Ht (in)	N/A	N/A	Gutter X Slope (%)	N/A
N/A	Painted X Walk1?	No	N/A	Painted X Walk2?	No
	X Walk 1 Direction	To NW		X Walk 2 Direction	To SW
N/A	X Walk 1 Width (in)	N/A	N/A	X Walk 2 Width (in)	N/A
	X Walk 1 Slope (%)	0.9		X Walk 2 Slope (%)	2.1
	X Walk 1 X Slope (%)	1.3		X Walk 2 X Slope (%)	0.5

N/A	Ramp inside XWalk1?	N/A	N/A	Ramp inside XWalk2?	N/A
	Road Slope (%)	2.2	N/A	Clear Space?	N/A
	Road X Slope (%)	3.2	N/A	Clear Space to XWalk (in)	N/A
N/A	Any Obstructions?	N/A	N/A	Storm Grate/Utility Hazard?	N/A
	Obstruction Type			Storm Grate/Utility Type	
		N/A			N/A
		Yes		Surface Condition? (G/P)	Good

Possible Solutions:

Remove & Replace Curb Ramp With Two New Directional Ramps or Equivalent.
