# Access Compliance Report

## Public Rights-of-Way

### (Curb Ramps)

| Intersection ID: 14620 | Main Street: EUCLID_AV | Cross Street: MCDONALD_AV | Location: E |

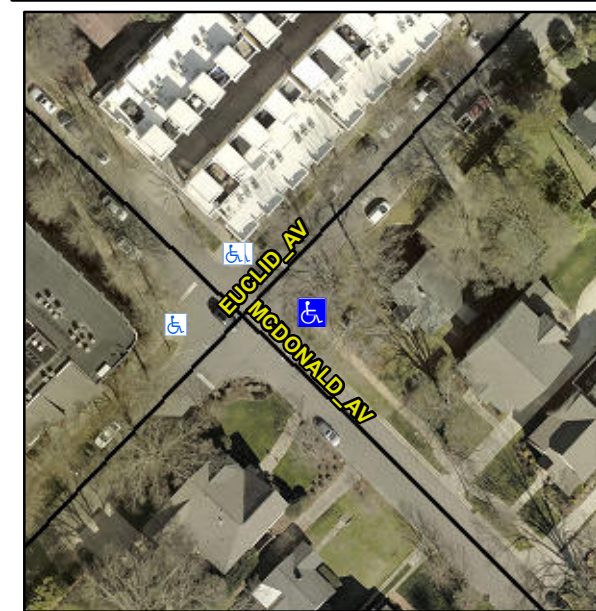
**R305.1.4**

| Compliance | Description | Data | Compliance | Description | Data |
|---|---|---|---|---|---|
| Yes | Landing X Slope (%) | 0.3 | No | DWS Full Width? | No |

**Remove & Replace Detectable Warning System.**

Total Cost: \$ 800.00
