Access Compliance Report

Public Rights-of-Way

(Curb Ramps)

Intersection ID: 46144	Main Street: EASTFIELD_VILLAGE_LN	Cross Street: ROCKY_FORD_CLUB_RD	Location: E
ADA ID: 8FBE9EC9FC34	Ramp Type: BlendTrans1	Initial Pass/Fail: Pass	Overall Compliance: No
			Severity Score: 15

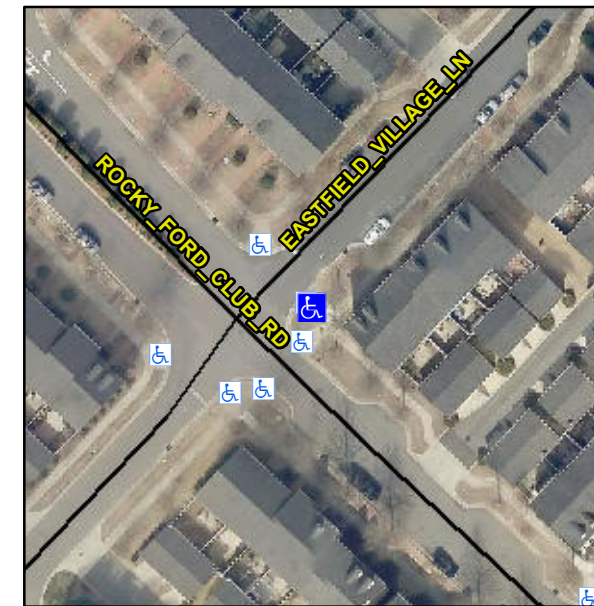
Compliance	Description	Data	Compliance	Description	Data
N/A	Ramp Length (in)	194.0	Yes	BlendTrans Slope (%)	2.7
Yes	Ramp Width (in)	48.0	Yes	BlendTrans XSlope (%)	0.1
N/A	Flare Type LT	Sloped	N/A	Flare Type RT	Sloped
N/A	Flare Slope LT (%)	10.2	N/A	Flare Slope RT (%)	8.4
N/A	Flare Traversable LT?	No	N/A	Flare Traversable RT?	No
Yes	Landing Length (in)	59.0	Yes	DWS Provided?	Yes
Yes	Landing Width (in)	48.0	Yes	DWS Contrast?	Yes
No	Landing Slope (%)	2.7	Yes	DWS Length (in)	24.0
Yes	Landing X Slope (%)	0.8	Yes	DWS Full Width?	Yes
N/A	Landing Curb? (Y/N)	No	No	DWS Offset (in)	3.5
N/A	Shared Landing?	No			
Yes	Gutter Ponding?	No	Yes	Gutter Slope (%)	2.6
No	Gutter Lip Ht (in)	1.0	Yes	Gutter X Slope (%)	1.2
N/A	Painted X Walk1?	No	N/A	Painted X Walk2?	N/A
	X Walk 1 Direction	To NW		X Walk 2 Direction	N/A
	X Walk 1 Width (in)	N/A		X Walk 2 Width (in)	N/A
	X Walk 1 Slope (%)	0.4		X Walk 2 Slope (%)	N/A
	X Walk 1 X Slope (%)	0.9		X Walk 2 X Slope (%)	N/A

N/A	Ramp inside XWalk1?	N/A	N/A	Ramp inside XWalk2?	N/A
	Road Slope (%)	0.9		Clear Space?	Yes
	Road X Slope (%)	0.4	N/A	Clear Space to XWalk (in)	N/A
Yes	Any Obstructions?	No	Yes	Storm Grate/Utility Hazard?	No
	Obstruction Type			Storm Grate/Utility Type	
		N/A			N/A
			Yes	Surface Condition? (G/P)	Good
			N/A	Curb Slope (%)	N/A

Remove & Replace Curb Ramp With Two New Directional Ramps or Equivalent. Grind Gutter Lip.
