# Access Compliance Report

## Public Rights-of-Way

### (Curb Ramps)

| Intersection ID: N/A | Main Street: TUCKASEEGEE_RD | Cross Street: N/A | Location: E |

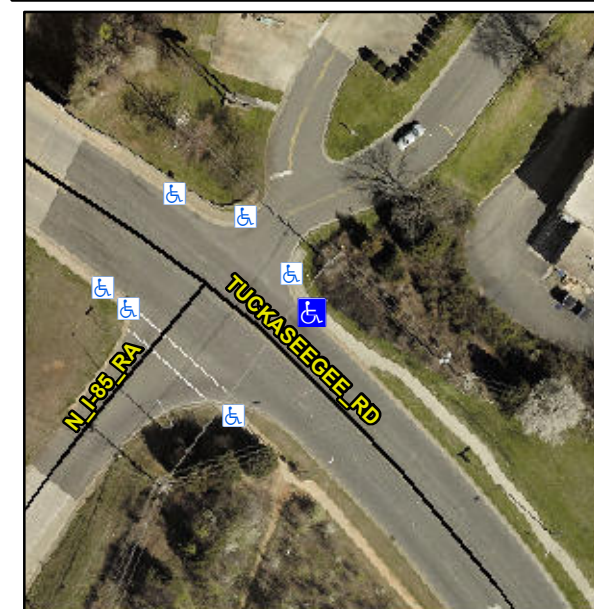
**Not Found, R304.5.1, R304.2.2**

| Compliance | Description | Data | Compliance | Description | Data |
|---|---|---|---|---|---|
| N/A | Ramp Length (in) | 61.0 | No | Ramp Slope (%) | 10.5 |
| No | Ramp Width (in) | 27.0 | Yes | Ramp XSlope (%) | 1.3 |

**Remove & Replace Entire Ramp.**
