Access Compliance Report

Public Rights-of-Way

(Curb Ramps)

Intersection ID: 30314	Main Street: ROCKET_LN	Cross Street: SHINKANSEN_DR	Location: SW
ADA ID: 8FCEFBAC0597	Ramp Type: PerpDiag	Initial Pass/Fail: Fail	Overall Compliance: No
		Severity Score: 25

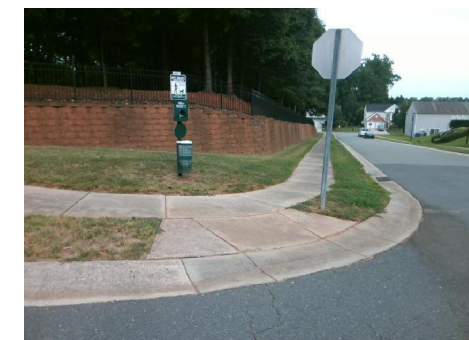
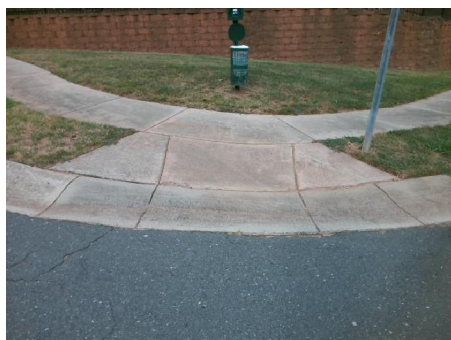
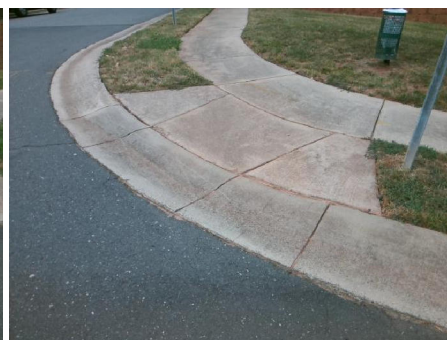
Not Found, R304.5.3

Compliance	Description	Data	Compliance	Description	Data
N/A	Ramp Length (in)	44.0	Yes	Ramp Slope (%)	6.5
Yes	Ramp Width (in)	48.0	No	Ramp XSlope (%)	7.9
N/A	Flare Type LT	N/A	N/A	Flare Type RT	N/A
N/A	Flare Slope LT (%)	N/A	N/A	Flare Slope RT (%)	N/A
N/A	Flare Traversable LT?	N/A	N/A	Flare Traversable RT?	N/A
N/A	Landing Length (in)	N/A	N/A	DWS Provided?	N/A
N/A	Landing Width (in)	N/A	N/A	DWS Contrast?	N/A
N/A	Landing Slope (%)	N/A	N/A	DWS Length (in)	N/A
N/A	Landing X Slope (%)	N/A	N/A	DWS Full Width?	N/A
N/A	Landing Curb? (Y/N)	N/A	N/A	DWS Offset (in)	N/A
N/A	Shared Landing?	N/A			
N/A	Gutter Ponding?	N/A	N/A	Gutter Slope (%)	N/A
N/A	Gutter Lip Ht (in)	1.0	N/A	Gutter X Slope (%)	N/A
N/A	Painted X Walk1?	No	N/A	Painted X Walk2?	No
	X Walk 1 Direction	To SE		X Walk 2 Direction	To NE
N/A	X Walk 1 Width (in)	N/A	N/A	X Walk 2 Width (in)	N/A
	X Walk 1 Slope (%)	5.3		X Walk 2 Slope (%)	0.7
	X Walk 1 X Slope (%)	3.7		X Walk 2 X Slope (%)	5.3

N/A	Ramp inside XWalk1?	N/A	N/A	Ramp inside XWalk2?	N/A
	Road Slope (%)	6.9	N/A	Clear Space?	N/A
	Road X Slope (%)	2.4	N/A	Clear Space to XWalk (in)	N/A
N/A	Any Obstructions?	N/A	N/A	Storm Grate/Utility Hazard?	N/A
	Obstruction Type			Storm Grate/Utility Type	
		N/A			N/A
			Yes	Surface Condition? (G/P)	Good

Remove & Replace Curb Ramp With Two New Directional Ramps or Equivalent.

Total Cost: \$ 3200.00
