Access Compliance Report

Public Rights-of-Way

(Curb Ramps)

Intersection ID: 5433	Main Street: PLEASANT GROVE RD	Cross Street: OLD PLANK RD	Location: SE
ADA ID: 8FE05CA22BF2	Ramp Type: Perp	Initial Pass/Fail: Fail	Overall Compliance: No
Codes/Mitigation Info/Possible Solution		Field Measurements/Component Compliance	
Severity Score: 13.75

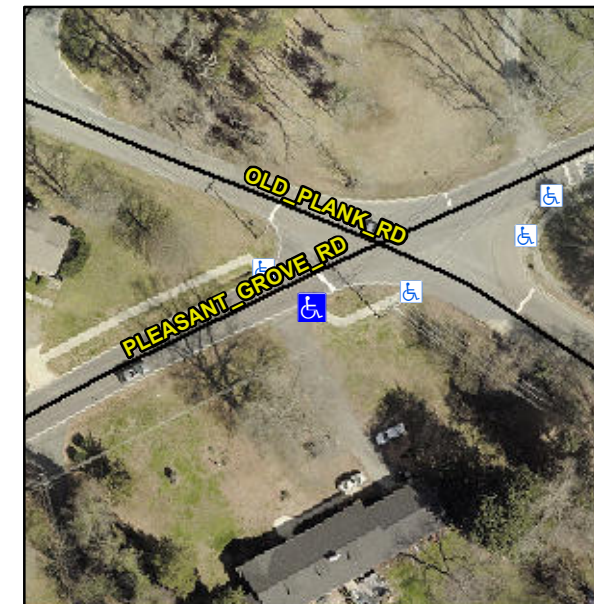
Compliance	Description	Data	Compliance	Description	Data
N/A	Ramp Length (in)	88.0	No	Ramp Slope (%)	9.1
Yes	Ramp Width (in)	58.0	No	Ramp XSlope (%)	2.7
N/A	Flare Type LT	N/A	N/A	Flare Type RT	N/A
N/A	Flare Slope LT (%)	N/A	N/A	Flare Slope RT (%)	N/A
N/A	Flare Traversable LT?	N/A	N/A	Flare Traversable RT?	N/A
N/A	Landing Length (in)	N/A	N/A	DWS Provided?	N/A
N/A	Landing Width (in)	N/A	N/A	DWS Contrast?	N/A
N/A	Landing Slope (%)	N/A	N/A	DWS Length (in)	N/A
N/A	Landing X Slope (%)	N/A	N/A	DWS Full Width?	N/A
N/A	Landing Curb? (Y/N)	N/A	N/A	DWS Offset (in)	N/A
N/A	Shared Landing?	N/A			
N/A	Gutter Ponding?	N/A	N/A	Gutter Slope (%)	N/A
N/A	Gutter Lip Ht (in)	N/A	N/A	Gutter X Slope (%)	N/A
N/A	Painted X Walk1?	No	N/A	Painted X Walk2?	N/A
	X Walk 1 Direction	To NW		X Walk 2 Direction	N/A
N/A	X Walk 1 Width (in)	N/A	N/A	X Walk 2 Width (in)	N/A
	X Walk 1 Slope (%)	5.7		X Walk 2 Slope (%)	N/A
	X Walk 1 X Slope (%)	0.8		X Walk 2 X Slope (%)	N/A

N/A	Ramp inside XWalk1?	N/A	N/A	Ramp inside XWalk2?	N/A
	Road Slope (%)	N/A	N/A	Clear Space?	N/A
	Road X Slope (%)	N/A	N/A	Clear Space to XWalk (in)	N/A
N/A	Any Obstructions?	N/A	N/A	Storm Grate/Utility Hazard?	N/A
	Obstruction Type			Storm Grate/Utility Type	
		N/A			N/A
			Yes	Surface Condition? (G/P)	Good

Possible Solutions:

Remove & Replace Entire Ramp.
