## **Access Compliance Report Public Rights-of-Way** (Curb Ramps)

Intersection ID: 11408 Main Street: N\_SMITH\_ST Cross Street: W\_8TH\_ST Location:

**Overall Compliance: No ADA ID: 8FE46CE9101D** Ramp Type: BlendTrans2 Initial Pass/Fail: Pass **Severity Score:** 17.5

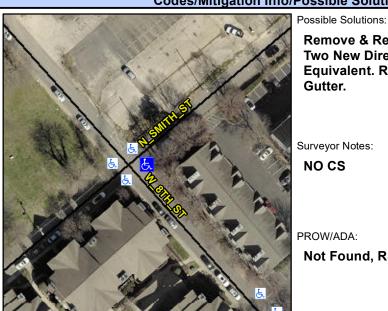
NO CS

Not Found, R305, R302.7.2, R304.5.3

Compliance Description		Data	Compliance Description		Data
N/A	Ramp Length (in)	87.0	Yes	BlendTrans Slope (%)	5.0
Yes	Ramp Width (in)	57.0	Yes	BlendTrans XSlope (%)	0.1
N/A	Flare Type LT	Sloped	N/A	Flare Type RT	Sloped
Yes	Flare Slope LT (%)	5.9	Yes	Flare Slope RT (%)	3.3
N/A	Flare Traversable LT?	Yes	N/A	Flare Traversable RT?	Yes
N/A	Landing Length (in)	N/A	No	DWS Provided?	No
N/A	Landing Width (in)	N/A	N/A	DWS Contrast?	No
N/A	Landing Slope (%)	N/A	N/A	DWS Length (in)	N/A
N/A	Landing X Slope (%)	N/A	N/A	DWS Full Width?	No
N/A	Landing Curb? (Y/N)	No	N/A	DWS Offset (in)	N/A
N/A	Shared Landing?	No			
Yes	Gutter Ponding?	No	Yes	Gutter Slope (%)	4.5
No	Gutter Lip Ht (in)	0.5	No	Gutter X Slope (%)	2.2
N/A	Painted X Walk1?	No	N/A	Painted X Walk2?	No
	X Walk 1 Direction	To NW		X Walk 2 Direction	To SW
	X Walk 1 Width (in)	N/A		X Walk 2 Width (in)	N/A
	X Walk 1 Slope (%)	2.2		X Walk 2 Slope (%)	1.1
	X Walk 1 X Slope (%)	1.0		X Walk 2 X Slope (%)	0.1

N/A	Ramp inside XWalk1?	N/A	N/A	Ramp inside XWalk2?	N/A
	Road Slope (%)	0.9		Clear Space?	Yes
	Road X Slope (%)	3.2	N/A	Clear Space to XWalk (in)	N/A
Yes	Any Obstructions?	No	Yes	Storm Grate/Utility Hazard?	No
	Obstruction Type		l	Storm Grate/Utility Type	
		N/A	l		N/A
			Yes	Surface Condition? (G/P)	Good
	TI I C		No	Curb Slope (%)	13.1

Street 1 Name Stop Condition-Street 1 Street 2 Name Stop Condition-Street 2 **N SMITH ST** None W 8TH ST StopSign Remove & Replace Curb Ramp With Two New Directional Ramps or Equivalent. Remove & Replace Gutter.
