Access Compliance Report

Public Rights-of-Way

(Curb Ramps)

Intersection ID: 28863	Main Street: HAMPTON_PLACE_DR	Cross Street: DELAMERE_LN	Location: S
ADA ID: 8FF218B6683B	Ramp Type: PerpDiag	Initial Pass/Fail: Fail	Overall Compliance: No
Severity Score: 8.75			
Codes/Mitigation Info/Possible Solution		Field Measurements/Component Compliance

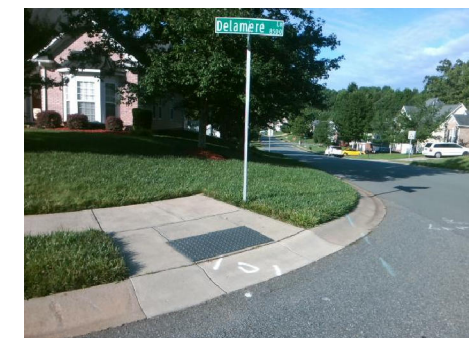
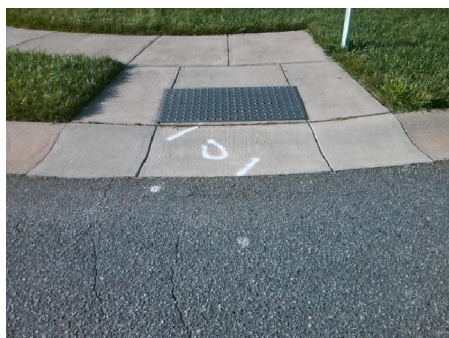
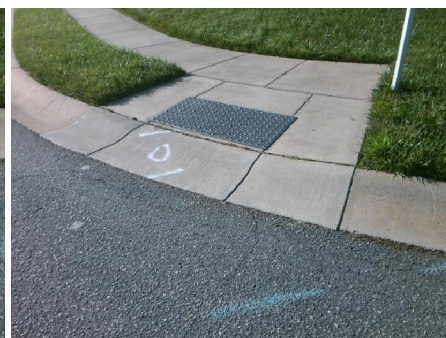
Street 1 Name DELAMERE LN
 Stop Condition-Street 2 StopSign
 Street 2 Name HAMPTON PLACE DR
 Stop Condition-Street 1 None
