Access Compliance Report Public Rights-of-Way (Curb Ramps)

Intersection ID: 19885 Main Street: ASHLEY_FARM_DR Cross Street: RHEINWOOD_CT Location: E

ADA ID: 8FF9B5A04863 Ramp Type: PerpDiag Initial Pass/Fail: Fail Overall Compliance: No Severity Score: 33.75

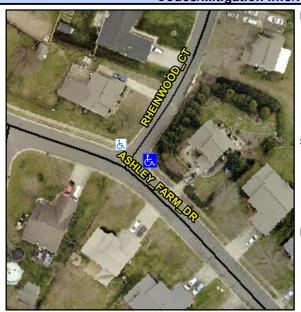
PROW/ADA:
R304.5.1, R304.5.3

Compliance Description Data Compliance Description Data Yes Ramp Slope (%) N/A Ramp Length (in) 96.0 7.7 40.0 No Ramp XSlope (%) No Ramp Width (in) 8.4 N/A N/A Flare Type LT N/A Flare Type RT N/A N/A N/A N/A Flare Slope RT (%) N/A Flare Slope LT (%) N/A Flare Traversable LT? N/A N/A Flare Traversable RT? N/A N/A N/A N/A **DWS Provided?** N/A Landing Length (in) N/A Landing Width (in) N/A N/A **DWS Contrast?** N/A N/A N/A N/A Landing Slope (%) DWS Length (in) N/A N/A Landing X Slope (%) N/A N/A DWS Full Width? N/A N/A Landing Curb? (Y/N) N/A N/A DWS Offset (in) N/A N/A N/A Shared Landing? N/A Gutter Ponding? N/A N/A Gutter Slope (%) N/A N/A Gutter Lip Ht (in) N/A N/A Gutter X Slope (%) N/A N/A Painted X Walk1? No N/A Painted X Walk2? No X Walk 1 Direction To NW X Walk 2 Direction To SW N/A N/A X Walk 1 Width (in) X Walk 2 Width (in) N/A X Walk 1 Slope (%) 0.1 X Walk 2 Slope (%) 6.3 X Walk 1 X Slope (%) 6.1 X Walk 2 X Slope (%) 0.3 N/A N/A N/A Ramp inside XWalk2? N/A Ramp inside XWalk1? Road Slope (%) 5.8 N/A Clear Space? N/A N/A Road X Slope (%) 3.2 Clear Space to XWalk (in) N/A N/A N/A N/A Any Obstructions? Storm Grate/Utility Hazard? N/A **Obstruction Type** Storm Grate/Utility Type N/A N/A Yes Surface Condition? (G/P) Good

Remove & Replace Curb Ramp With
Two New Directional Ramps or
Equivalent.

Total Cost: \$ 3200.00
