Access Compliance Report

Public Rights-of-Way (Curb Ramps)

Intersection ID: 4866	Main Street: E_MALLARD_CREEK_CHURCH_RD	Cross Street: N_TRYON_ST	Location: N
ADA ID: 8FFF55D2C999	Ramp Type: Perp	Initial Pass/Fail: Fail	Overall Compliance: No
Severity Score: 33.75			
Codes/Mitigation Info/Possible Solution		Field Measurements/Component Compliance

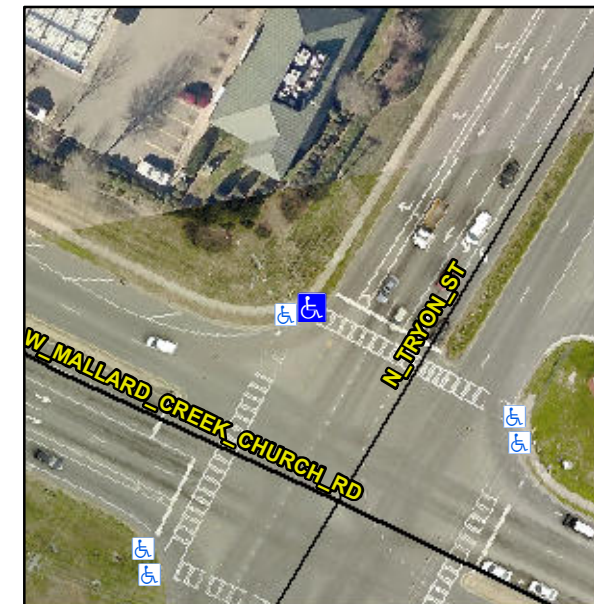
R304.5.1, R304.2.2

Compliance	Description	Data	Compliance	Description	Data
N/A	Ramp Length (in)	108.0	No	Ramp Slope (%)	14.5
No	Ramp Width (in)	40.0	Yes	Ramp XSlope (%)	1.1
N/A	Flare Type LT	N/A	N/A	Flare Type RT	N/A
N/A	Flare Slope LT (%)	N/A	N/A	Flare Slope RT (%)	N/A
N/A	Flare Traversable LT?	N/A	N/A	Flare Traversable RT?	N/A
N/A	Landing Length (in)	N/A	N/A	DWS Provided?	N/A
N/A	Landing Width (in)	N/A	N/A	DWS Contrast?	N/A
N/A	Landing Slope (%)	N/A	N/A	DWS Length (in)	N/A
N/A	Landing X Slope (%)	N/A	N/A	DWS Full Width?	N/A
N/A	Landing Curb? (Y/N)	N/A	N/A	DWS Offset (in)	N/A
N/A	Shared Landing?	N/A			
N/A	Gutter Ponding?	N/A	N/A	Gutter Slope (%)	N/A
N/A	Gutter Lip Ht (in)	N/A	N/A	Gutter X Slope (%)	N/A
N/A	Painted X Walk1?	Yes	N/A	Painted X Walk2?	N/A
	X Walk 1 Direction	To SE		X Walk 2 Direction	N/A
N/A	X Walk 1 Width (in)	97.0	N/A	X Walk 2 Width (in)	N/A
	X Walk 1 Slope (%)	0.9		X Walk 2 Slope (%)	N/A
	X Walk 1 X Slope (%)	2.9		X Walk 2 X Slope (%)	N/A

Remove & Replace Entire Ramp.
