# Access Compliance Report

## Public Rights-of-Way

| Intersection ID: 11566 | Main Street: GRANDIN_RD | Cross Street: LITAKER_AV | Location: SW |
| ADA ID: 9002F4087D16 | Ramp Type: BlendTrans1 | Initial Pass/Fail: Pass | Overall Compliance: No |

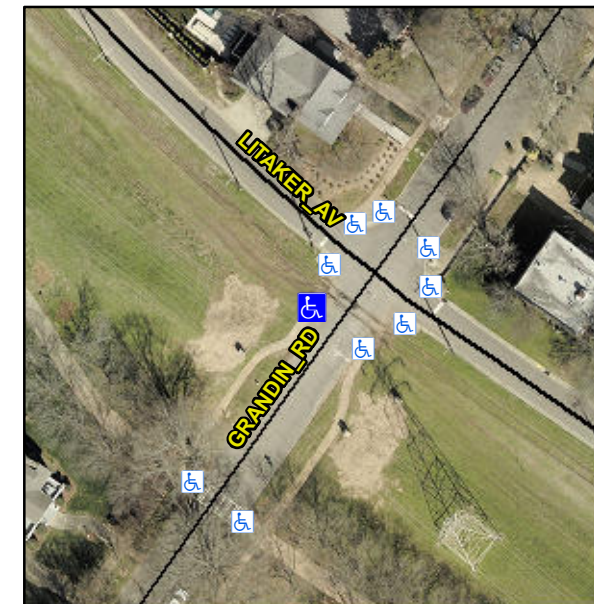
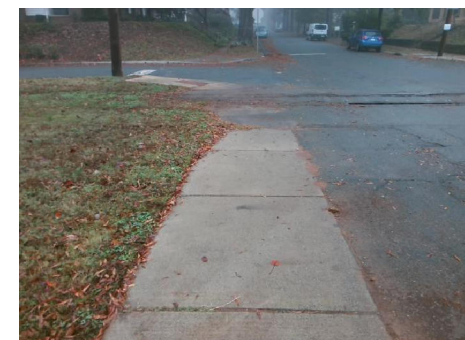
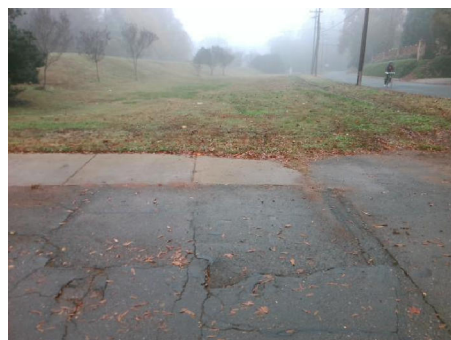
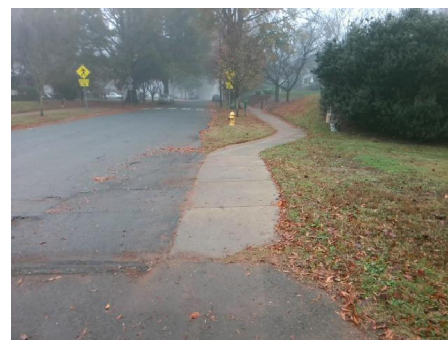
| Severity Score: 10.25 | | | |

| Compliance | Description | Data | Compliance | Description | Data |
|---|---|---|---|---|---|
| N/A | Ramp Length (in) | 60.0 | Yes | BlendTrans Slope (%) | 3.1 |
| Yes | Ramp Width (in) | 56.0 | No | BlendTrans XSlope (%) | 2.5 |
| Yes | Landing Length (in) | 60.0 | No | DWS Provided? | No |
| No | Landing X Slope (%) | 2.6 | N/A | DWS Full Width? | No |

Possible Solutions:

**Remove & Replace Curb Ramp With Two New Directional Ramps or Equivalent.**

**R304.5.3, R305**

Total Cost: \$ 3200.00
