# Access Compliance Report

## Public Rights-of-Way

### (Curb Ramps)

| Intersection ID: 12589 | Main Street: BELVEDERE_AV | Cross Street: TRUMAN_RD | Location: NE |

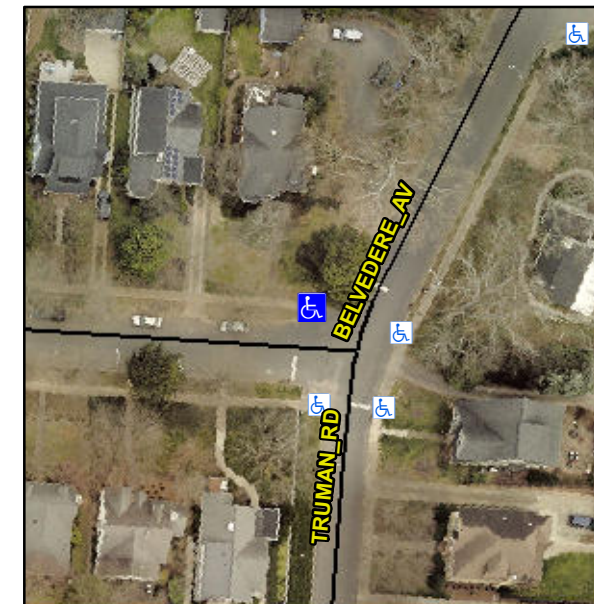
| ADA ID: 900DFCB802FF | Ramp Type: PerpDiag | Initial Pass/Fail: Fail | Overall Compliance: No |
| Severity Score: 21.25 | | | |

**R304.5.1, R304.5.3**

| Compliance | Description | Data | Compliance | Description | Data |
|---|---|---|---|---|---|
| No | Ramp Width (in) | 39.0 | No | Ramp XSlope (%) | 6.5 |

**Remove & Replace Curb Ramp With Two New Directional Ramps or Equivalent.**

Total Cost: \$ 3200.00

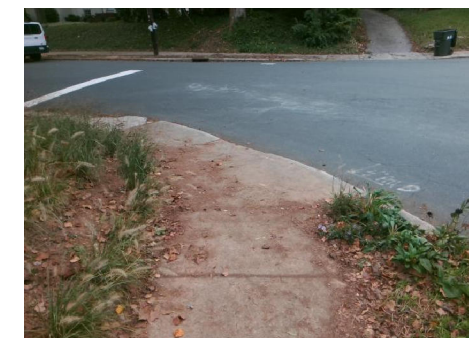
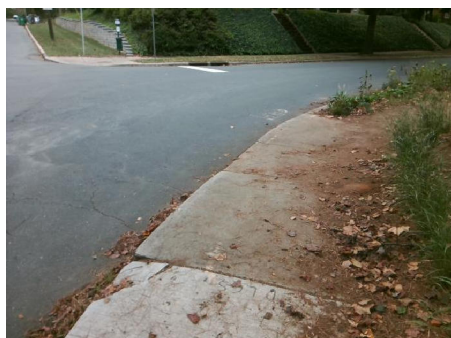
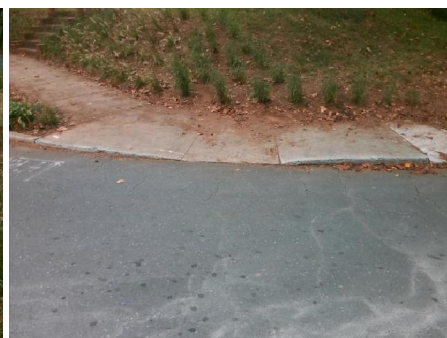
| Compliance | Description | Data | Compliance | Description | Data |
|---|---|---|---|---|---|
| N/A | Ramp Length (in) | 67.0 | Yes | Ramp Slope (%) | 5.6 |
| | | | Yes | Surface Condition? (G/P) | Good |
