# Access Compliance Report

## Public Rights-of-Way

### (Curb Ramps)

Intersection ID: 15916	Main Street: BRANDON_RD	Cross Street: PEMBROKE_AV	Location: SE
ADA ID: 90174AF162F6	Ramp Type: PerpDiag	Initial Pass/Fail: Fail	Overall Compliance: No
Codes/Mitigation Info/Possible Solution		Field Measurements/Component Compliance	
Severity Score: 12.5

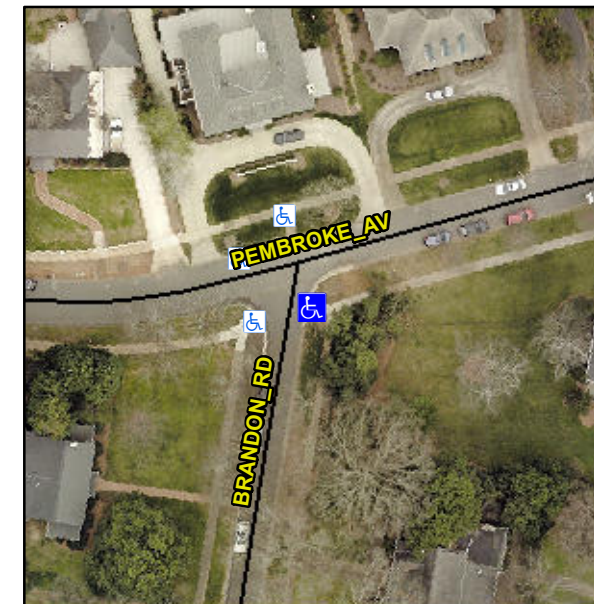
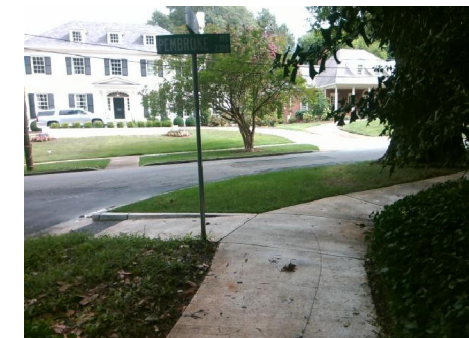
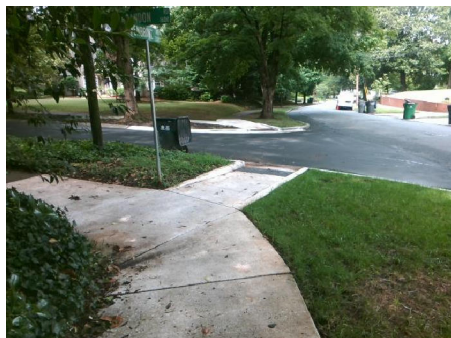
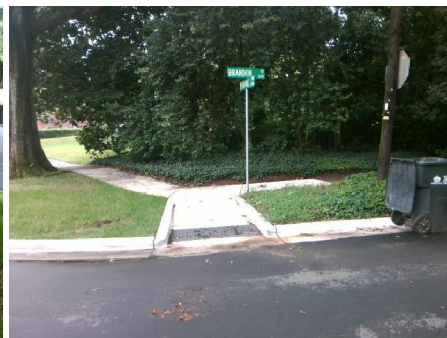
Compliance	Description	Data	Compliance	Description	Data
N/A	Ramp Length (in)	119.0	No	Ramp Slope (%)	8.8
Yes	Ramp Width (in)	55.0	Yes	Ramp XSlope (%)	2.0
N/A	Flare Type LT	N/A	N/A	Flare Type RT	N/A
N/A	Flare Slope LT (%)	N/A	N/A	Flare Slope RT (%)	N/A
N/A	Flare Traversable LT?	N/A	N/A	Flare Traversable RT?	N/A
N/A	Landing Length (in)	N/A	N/A	DWS Provided?	N/A
N/A	Landing Width (in)	N/A	N/A	DWS Contrast?	N/A
N/A	Landing Slope (%)	N/A	N/A	DWS Length (in)	N/A
N/A	Landing X Slope (%)	N/A	N/A	DWS Full Width?	N/A
N/A	Landing Curb? (Y/N)	N/A	N/A	DWS Offset (in)	N/A
N/A	Shared Landing?	N/A			
N/A	Gutter Ponding?	N/A	N/A	Gutter Slope (%)	N/A
N/A	Gutter Lip Ht (in)	N/A	N/A	Gutter X Slope (%)	N/A
N/A	Painted X Walk1?	No	N/A	Painted X Walk2?	No
	X Walk 1 Direction	To N		X Walk 2 Direction	To W
N/A	X Walk 1 Width (in)	N/A	N/A	X Walk 2 Width (in)	N/A
	X Walk 1 Slope (%)	0.3		X Walk 2 Slope (%)	1.5
	X Walk 1 X Slope (%)	0.1		X Walk 2 X Slope (%)	0.7

N/A	Ramp inside XWalk1?	N/A	N/A	Ramp inside XWalk2?	N/A
	Road Slope (%)	0.0	N/A	Clear Space?	N/A
	Road X Slope (%)	0.0	N/A	Clear Space to XWalk (in)	N/A
N/A	Any Obstructions?	N/A	N/A	Storm Grate/Utility Hazard?	N/A
	Obstruction Type			Storm Grate/Utility Type	
		N/A			N/A
		Yes		Surface Condition? (G/P)	Good

**Remove & Replace Curb Ramp With Two New Directional Ramps or Equivalent.**
