Access Compliance Report

Public Rights-of-Way

(Curb Ramps)

Intersection ID: 10162	Main Street: E_SUGAR_CREEK_RD	Cross Street: THE_PLAZA	Location: NW
ADA ID: 9021665B7E3F	Ramp Type: PerpDiag	Initial Pass/Fail: Fail	Overall Compliance: No
		Severity Score: 37.5

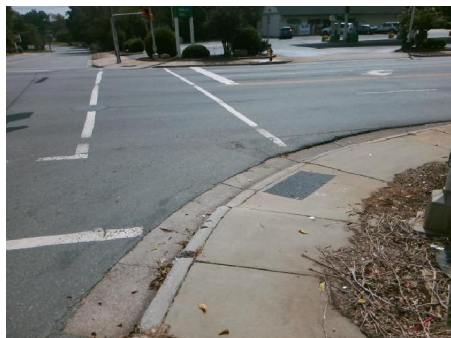
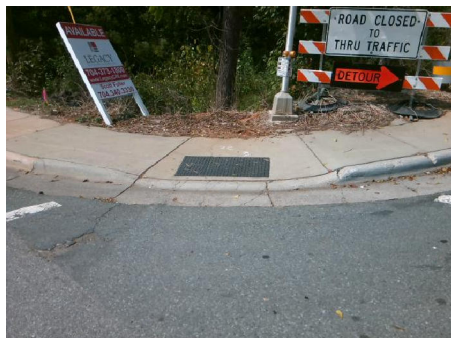
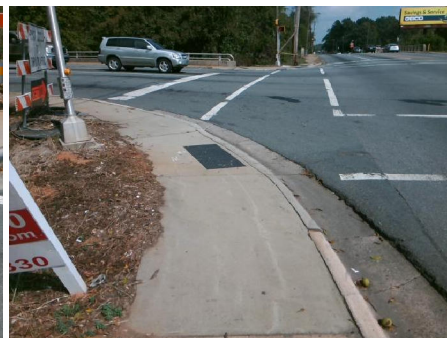
Compliance	Description	Data	Compliance	Description	Data
N/A	Ramp Length (in)	59.0	No	Ramp Slope (%)	8.7
Yes	Ramp Width (in)	60.0	No	Ramp XSlope (%)	7.2
N/A	Flare Type LT	N/A	N/A	Flare Type RT	N/A
N/A	Flare Slope LT (%)	N/A	N/A	Flare Slope RT (%)	N/A
N/A	Flare Traversable LT?	N/A	N/A	Flare Traversable RT?	N/A
N/A	Landing Length (in)	N/A	N/A	DWS Provided?	N/A
N/A	Landing Width (in)	N/A	N/A	DWS Contrast?	N/A
N/A	Landing Slope (%)	N/A	N/A	DWS Length (in)	N/A
N/A	Landing X Slope (%)	N/A	N/A	DWS Full Width?	N/A
N/A	Landing Curb? (Y/N)	N/A	N/A	DWS Offset (in)	N/A
N/A	Shared Landing?	N/A			
N/A	Gutter Ponding?	N/A	N/A	Gutter Slope (%)	N/A
N/A	Gutter Lip Ht (in)	1.0	N/A	Gutter X Slope (%)	N/A
N/A	Painted X Walk1?	Yes	N/A	Painted X Walk2?	Yes
	X Walk 1 Direction	To SE		X Walk 2 Direction	To NE
N/A	X Walk 1 Width (in)	143.0	N/A	X Walk 2 Width (in)	109.0
	X Walk 1 Slope (%)	0.1		X Walk 2 Slope (%)	5.8
	X Walk 1 X Slope (%)	4.2		X Walk 2 X Slope (%)	4.8

N/A	Ramp inside XWalk1?	Yes	N/A	Ramp inside XWalk2?	Yes
	Road Slope (%)	4.8	N/A	Clear Space?	N/A
	Road X Slope (%)	3.1	N/A	Clear Space to XWalk (in)	N/A
N/A	Any Obstructions?	N/A	N/A	Storm Grate/Utility Hazard?	N/A
	Obstruction Type			Storm Grate/Utility Type	
		N/A			N/A
			Yes	Surface Condition? (G/P)	Good

Remove & Replace Curb Ramp With Two New Directional Ramps or Equivalent.
