# Access Compliance Report

## Public Rights-of-Way

### (Curb Ramps)

Intersection ID: 25500	Main Street: PINEVILLE-MATTHEWS_RD	Cross Street: STRAWBERRY_LN	Location: SE
ADA ID: 90294FD7CEB1	Ramp Type: PerpDiag	Initial Pass/Fail: Fail	Overall Compliance: No
			Severity Score: 21.25

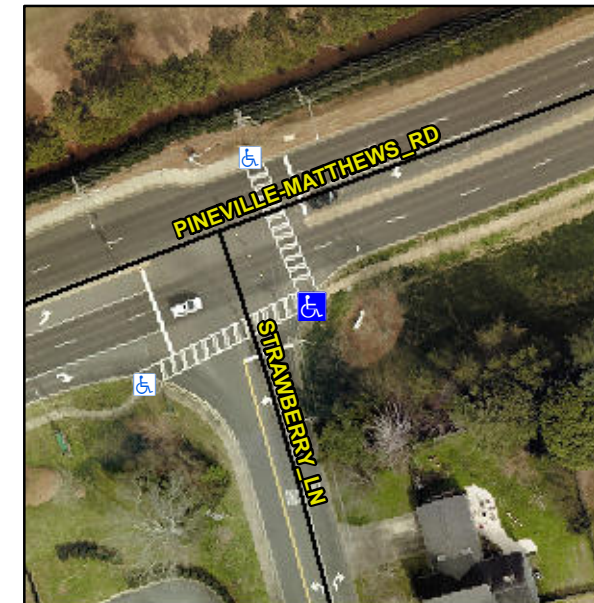
**Not Found, R304.5.1, R304.2.2**

Compliance	Description	Data	Compliance	Description	Data
N/A	Ramp Length (in)	60.0	No	Ramp Slope (%)	10.6
No	Ramp Width (in)	45.0	Yes	Ramp XSlope (%)	2.0
N/A	Flare Type LT	N/A	N/A	Flare Type RT	N/A
N/A	Flare Slope LT (%)	N/A	N/A	Flare Slope RT (%)	N/A
N/A	Flare Traversable LT?	N/A	N/A	Flare Traversable RT?	N/A
N/A	Landing Length (in)	N/A	N/A	DWS Provided?	N/A
N/A	Landing Width (in)	N/A	N/A	DWS Contrast?	N/A
N/A	Landing Slope (%)	N/A	N/A	DWS Length (in)	N/A
N/A	Landing X Slope (%)	N/A	N/A	DWS Full Width?	N/A
N/A	Landing Curb? (Y/N)	N/A	N/A	DWS Offset (in)	N/A
N/A	Shared Landing?	N/A			
N/A	Gutter Ponding?	N/A	N/A	Gutter Slope (%)	N/A
N/A	Gutter Lip Ht (in)	N/A	N/A	Gutter X Slope (%)	N/A
N/A	Painted X Walk1?	No	N/A	Painted X Walk2?	Yes
	X Walk 1 Direction	To NW		X Walk 2 Direction	To SW
N/A	X Walk 1 Width (in)	N/A	N/A	X Walk 2 Width (in)	69.0
	X Walk 1 Slope (%)	3.8		X Walk 2 Slope (%)	1.7
	X Walk 1 X Slope (%)	0.1		X Walk 2 X Slope (%)	5.2

N/A	Ramp inside XWalk1?	N/A	N/A	Ramp inside XWalk2?	Yes
	Road Slope (%)	2.0	N/A	Clear Space?	N/A
	Road X Slope (%)	3.2	N/A	Clear Space to XWalk (in)	N/A
N/A	Any Obstructions?	N/A	N/A	Storm Grate/Utility Hazard?	N/A
	Obstruction Type			Storm Grate/Utility Type	
		N/A			N/A
			Yes	Surface Condition? (G/P)	Good

**Remove & Replace Curb Ramp With Two New Directional Ramps or Equivalent.**

Total Cost: \$ 3200.00
